## ***Opel Astra-G, Vectra-B Model years 1998-2000 Opel Zafira Model years 1999-2000 All models with X18XE1 engine***

### **Irregular engine running Vehicle occasionally stalls; impaired idle speed control**

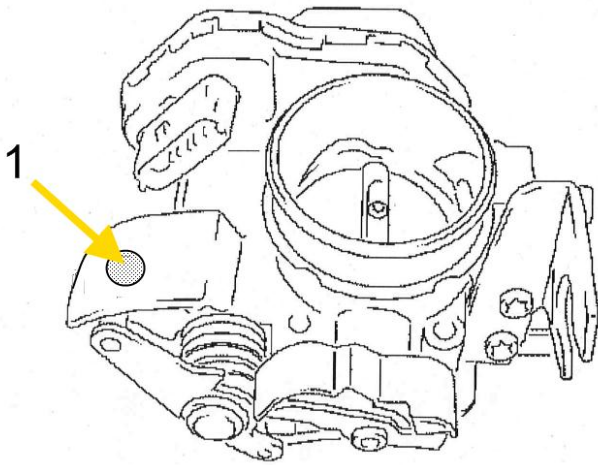
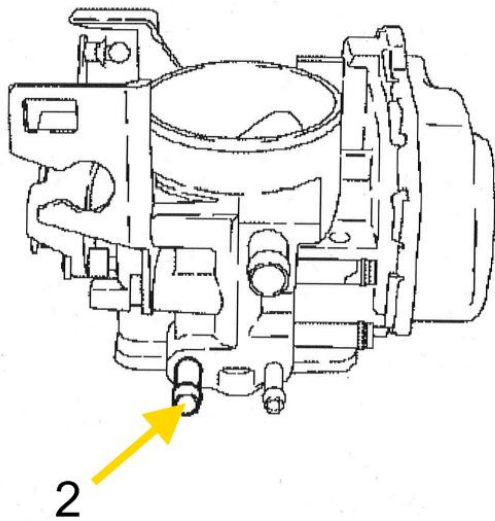
If the above-mentioned symptoms occur on these vehicles, this may be caused by a dirty throttle valve. In this case, check the blow-by hole and, if necessary, drill open to 2 mm. Afterwards, the ECU must be reprogrammed with a software modified for this purpose. The ECU software can only be updated by an authorised dealer.

Note: If a white dot (1) is already on the throttle body, this measure has already been done.

- Remove the throttle body
- Secure the throttle body in a vice, protecting the contact faces from damage with a cloth rag.
- Drill blow-by connector (2) open and clean.

Make sure that no chips remain in the throttle body.

- Install the throttle body
- Mark throttle body with white dot at position (1)
- Program engine control unit
- Teach throttle adaptation using diagnostic tool. Be sure to follow the instructions from the car manufacturer.
