Technical Guide.

Case study: Recurring Brake Judder.

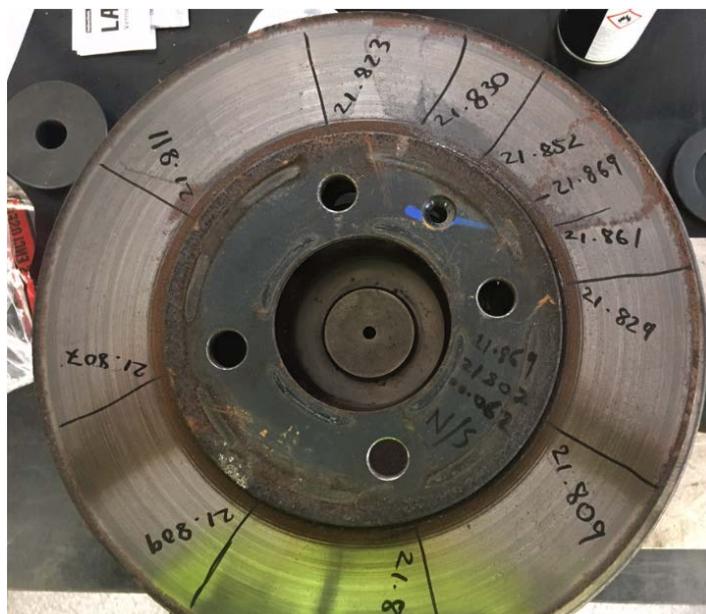
To confirm the condition of the brake discs, Techmate measured the thickness of both brake discs using at least 8 different points around the disc. The reason for this is to confirm whether the brake discs had indeed warped or whether the brake discs are suffering from excessive Disc Thickness Variation (please see our article 'Understanding Brake Judder' for more details). After measuring Techmate confirmed that the nearside front brake disc was suffering

from excessive Disc Thickness Variation as there was a variance of 0.05mm between the thickest and thinnest part of the brake disc. This variance will result in the symptom of 'brake judder' caused by the brake pads pulsating over the uneven surface. All Apec brake discs are tested before leaving the factory and will have a DTV reading $<0.013\text{mm}$.

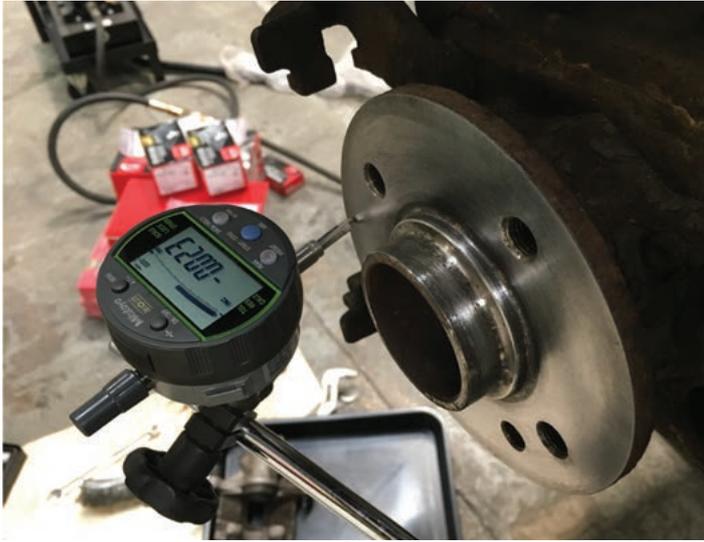
To confirm that the brake disc is in alignment, a run out measurement was taken to eliminate the brake disc as a source of misalignment. The maximum amount of tolerance for brake disc runout is $>0.08\text{mm}$. The runout reading from the nearside front 0.2mm which indicates that the brake disc has excessive lateral runout. To resolve this issue, Techmate needed to determine the cause of the runout. It is very common that the lateral runout is usually caused by the corrosion build up on the hub face, however the garage had been very meticulous and ensured that the hub surface was free of corrosion before fitting the new brake discs. To ensure that the hub was not causing the issue, a run out

measurement of the hub was taken. The maximum amount of tolerance for the hub runout is $>0.04\text{mm}$. The nearside hub gave a runout measurement of 0.08mm . As the hub was distorted it was causing the brake disc to be misaligned when it was fitted, hence affecting the even material transfer process, gradually causing the brake disc to develop excessive DTV and manifesting itself into a

brake judder after a few thousand driven miles. As this underlying issue with the hub was not detected at the point of fitting the new set of discs and pads, the issue had never been resolved therefore causing the brake judder to always return after a few thousand driven miles.

The nearside front hub was replaced and cured the issue. The garage involved is now insist that for every brake replacement carried out, they will measure the runout of the brake disc with a DTI gauge to prevent from missing an underlying issue. Techmate was delighted to have assisted to resolve the issue.
