# Accurate pressure diagnostics is key to success

## Skoda Yeti 1.6 TDI with poor performance

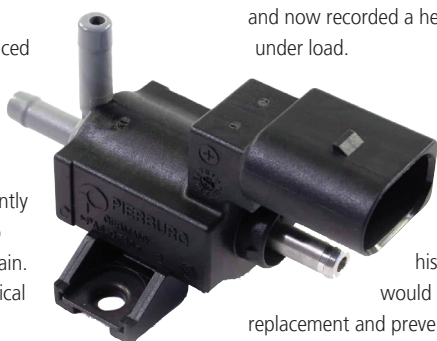
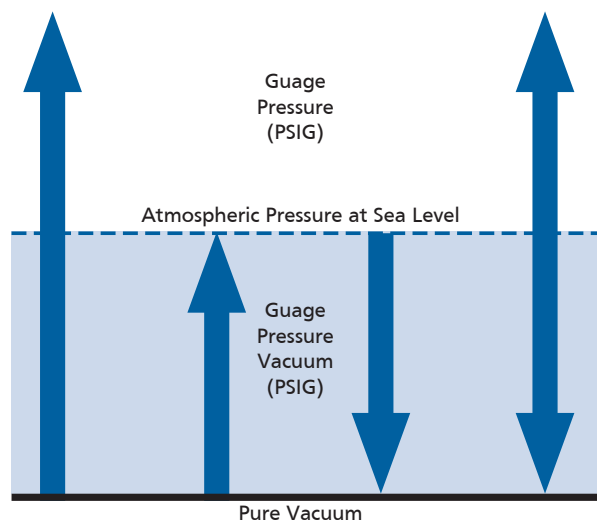
We started with some basic pressure tests, actual boost data under full load condition. This only achieved 120 kPa (1200 mb) a mere 200 millibar increase over atmospheric pressure.

We asked for some vacuum readings at the turbocharger, this was only 6 inHg (203 mb), indicating low vacuum. The technician had already "tested" the vacuum to the N75 solenoid, and he said it was OK. The signal controlling the N75 was checked, and these proved to be normal. In a typical N75 boost regulating valve, battery voltage is controlled through a duty cycle to regulate vacuum supply.

We then turned our attention back to the vacuum supply testing again. This time we wanted actual values at the input to the N75. It became clear the issue was low vacuum from the vacuum pump. The technician had sampled it with his finger and thought it was enough. We explained there was no calibration test for his finger. He needs to be more precise with pressure testing.

To test the output of the pump, we removed the brake servo line. The test proved the pump was healthy, so the Servo was the issue. To confirm the repair, a vacuum of 25 inHg (846 mb) was applied to the input of the N75 and the output vacuum had risen to 20 inHg (677 mb). The boost was retested and now recorded a healthy 245 kPa (2450 mb) under load.
