## Assembly camshaft damaged by timing belt failure

A recent call at the Helpline was from a new member for assistance with an unusual popping sound from the inlet. The vehicle, a 2013 Citroen Berlingo 1.6 HDI, had suffered a timing belt failure.

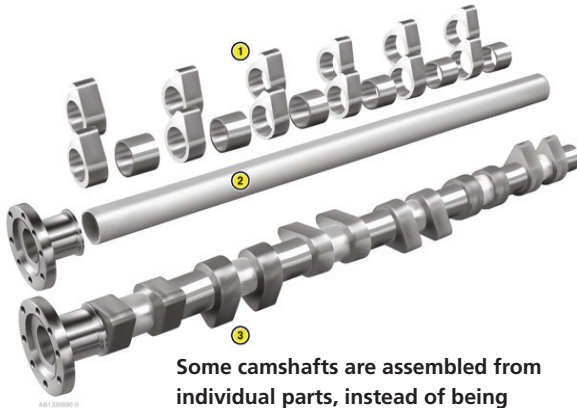
**Some camshafts are assembled from individual parts, instead of being machined as one piece**

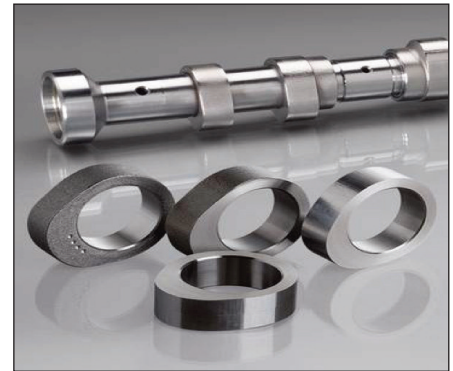
**Some camshafts are expanded with internal pressure to jam lobes into position**
