Rover Group

CLTB 0001

Auto Adjust Clutch Cable Issues

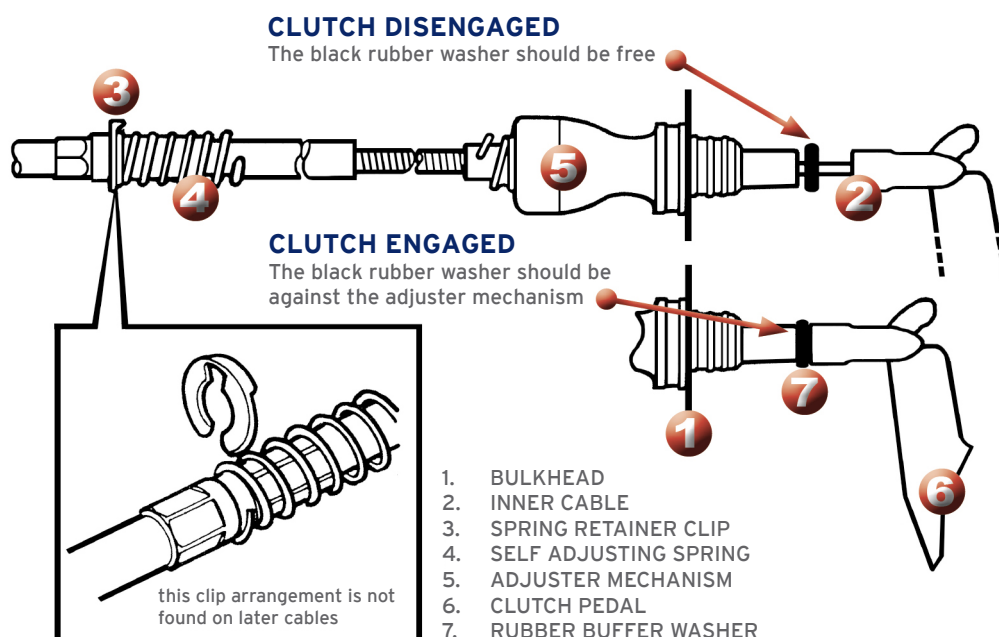
Concerns; Clutch engagement whilst pedal is still very close to floor and also a common cause of slip/premature wear to the driven plate facings. This can be due to failing action of the auto-adjust mechanism.

Method; Make sure that the auto adjust mechanism is correctly located in the bulkhead and that the ends of the cable have been located in the gearbox lever and to the top of the clutch pedal. The spring C clip should be fitted if required as per the illustration below. Check that when the pedal is at rest, that the rubber buffer washer can press against adjuster mechanism tube whilst still having some upward movement left before striking the pedal return stop. If not it may be due to too much slack in the cable, you may have to help it initially by holding the adjuster mechanism body with one hand and with the other hold around the self adjust spring moving them apart. (This will take out any slack)
