Tech Bits with Tim Stock

## Just one coat...Blinding a Mercedes radar unit

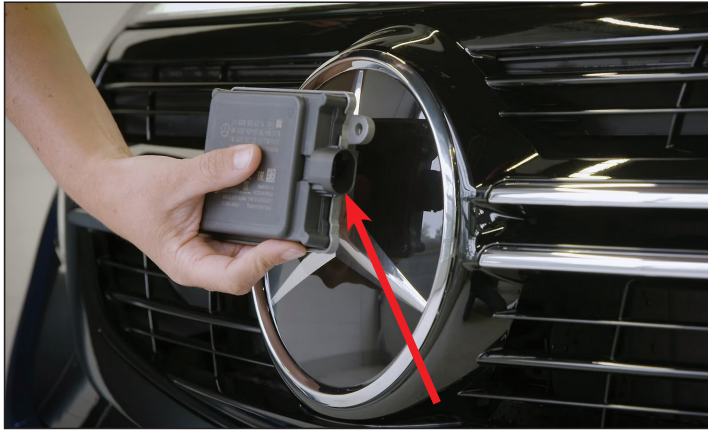
**The DISTRONIC unit is located behind the grille**

distance behind the vehicles in front of you. The fault, C174A, was present, indicating a fault with the calibration of the DISTRONIC module being outside of the permissible range. This unit is mounted behind the front grille, and is used to monitor objects in front of the vehicle. This data

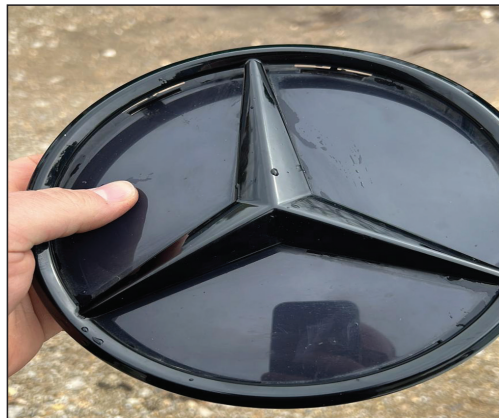
Armed with this information, we took a close look at the grille. Rather than replacing the grille they had painted it, and this had given rise to the sensor "Dirty" code. Also, by removing the DISTRONIC unit to clean, it had also created the need to recalibrate, using dedicated ADAS equipment.

We have seen this problem several other times on a variety of vehicles that have had the grilles replaced with after-market components that are not designed for models fitted with Radar Cruise sensors. The density of the plastic in the grille is an important consideration, as is also any paint or coating, as these sensors need to see through the grille unobstructed.

**The grille was painted black, disturbing the DISTRONIC unit function**

One of the possible fault causes was that the sensor was dirty, but cleaning did not successfully clear the fault. It is also important to note that once the unit is disturbed, it will require recalibration with dedicated ADAS equipment.
