BMW 218 with engine noise and poor engine performance

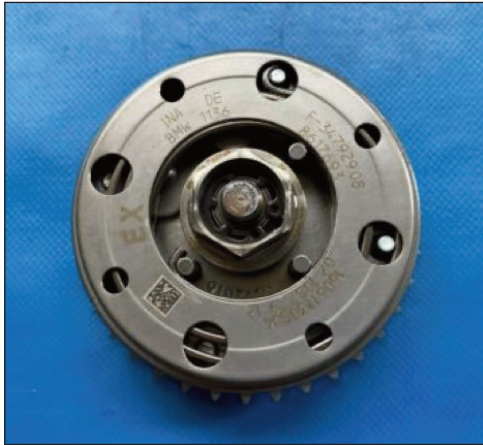
The circlip is in place in this image

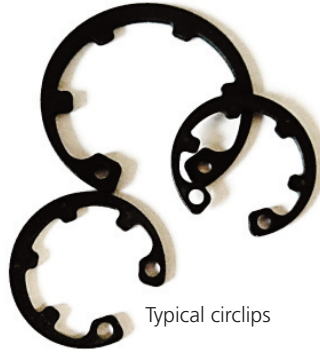
Typical circlips

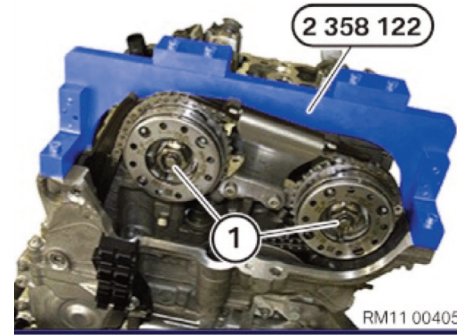
When inspecting the chain and pulleys, the circlip was missing on one pulley and loose on the other cam pulley. The missing circlip was found in the sump.

The two locations of the circlips, at 1

The clips can be purchased from springfasteners.co.uk

The correct name for the circlip is:
Increased Abutment 17mm Internal Circlip
D2000-0170

After replacing both circlips, and resetting the adaptations, the engine ran normally.
