BMW 325Gi - Knocking Front Suspension

Ford Focus - Rear Arm Removal

Opel Astra - Curious Burning Smell

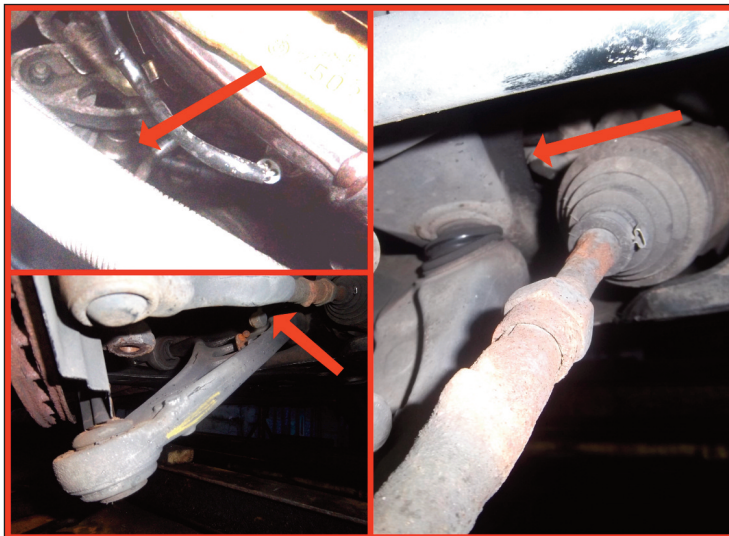
It was not too surprising to find that the offside front lower ball joint on this 2001 BMW 325i had excessive wear. The knocking noise it was making as it drove along the road was enough to indicate attention was needed.

One of the tricky parts of the job is undoing the top nut on the inner ball joint. On this car, it is not accessible using a socket, and if the joint begins to spin before the nut has been removed this adds to the problems.

The inner nut is not accessible with a socket and so a spanner is used through the underside

can be removed from the arm, this is not always easily achieved. In my mind, it is much quicker and easier to just replace the complete arm, along with the mount.

This one played by the rules, and although a spanner was needed to undo the inner nut (accessing this through the underside) it was soon removed. The rear mount unbolted easily and with both ball joints undone and split, the old arm was off.

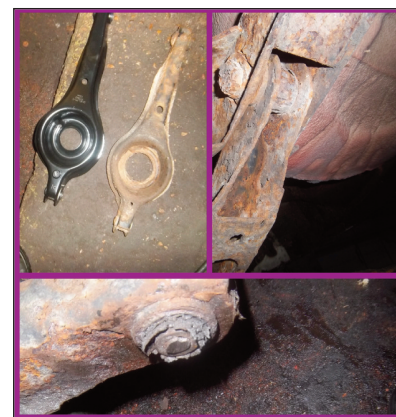
The corroded lower arm required the bolt cutting through to release it

The other more manageable problem, was the nearside lower arm had corroded badly and would soon be allowing the spring to push its way down and through to freedom.

The lower arms, in theory, should be quite easily replaceable. With this one, we discovered that the securing bolts were corroded firmly into the centre sleeve of the bush. No amount of penetrating fluid was going to free this one off, and so along with the new lower arm, we ordered up a couple of new bolts.

This allowed us to simply slice through the old bolts using the air-saw, releasing the arm which had first been supported with a jack against the spring pressure, to keep it in position once released.

Once the new arm and bolts were in place, the camber adjustment was checked. This needs to be done, as this is adjustable with the inner bolt locating on a cam washer to control the adjustment.

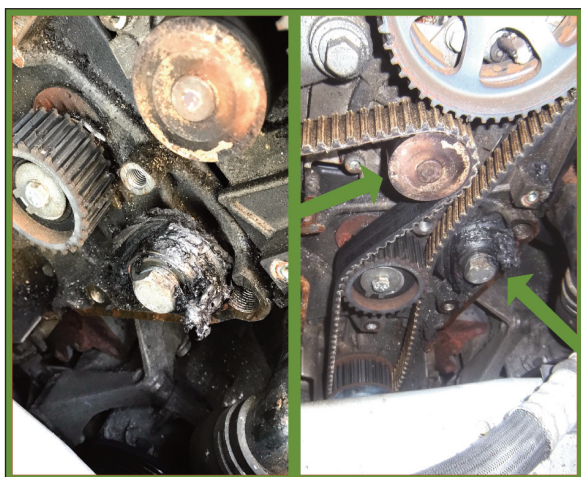
Once stripped down, I was pleased that the engine hadn't been started again. Not only had the water pump bearing collapsed, but the plastic tensioner on the cam-belt had melted away. This was probably the result of hot coolant spraying onto it whilst spinning, washing the bearing and then causing it to seize.

The timing belt had also jumped a tooth, proving how close this engine was to failure. Thankfully, the timing on this 1.9L diesel engine is quite easily set with the correct tools. Added to this, the new belt has marks to align with the pulleys, meant that once the new water pump, tensioners and belt were fitted, we could be confident that the valve timing would be correct.

Very close to disaster, the water pump had failed, and the tensioner had all but melted away
