BMW 5 Series - Seized turbo reduces power

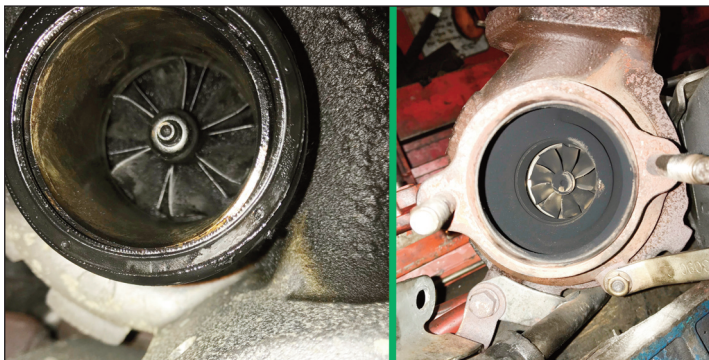
The impeller was sticking and would not spin freely when checked

I checked for codes in the ECU, and found none. I moved on to look at the mechanical problems that may have occurred, starting with the turbo. I found the impeller to be sticking. Instead of spinning freely and delivering a boost of air to the engine, it was actually acting as an obstruction in the induction system.

The turbo needed to be replaced. Along with the turbo, the oil feed pipe and oil return pipes needed to be checked and cleaned. I also ensured that the oil feed supply was good and that this wasn't the cause of the initial failure.

Once the new turbo was in place and the oil pipes had been primed, the engine was started and allowed to tick over for a short while before setting off on a test drive. Once on the road, the difference was easily noticeable and the customer was very happy to get the power restored.
