# A BMW Wheel Speed Sensor fault after a Botched Wiring Repair

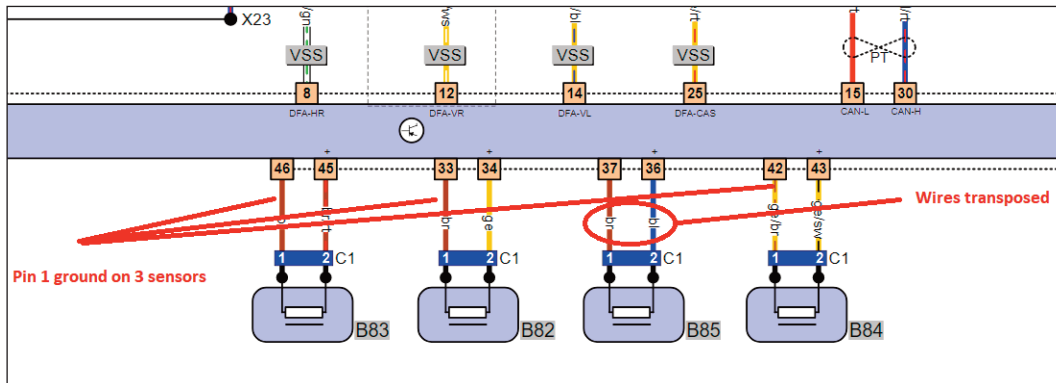
**The signal and ground wires to the left rear wheel speed sensor had been transposed by the car's owner while attempting a wiring repair under the seat**

found that the circuit to the sensor was reversed somewhere in the wiring loom. After opening up the loom, he found a poor repair attempt to wiring under the seat. The circuit wiring had been crossed during a failed attempt to repair damaged wiring. After repairing the loom and putting the circuit back to the correct orientation, all codes and faults were cleared.
