BMW X5 - when the Fix is not the Fix

This is an interesting case of a non-starting BMW X5. The workshop was called to start a BMW X5 E70 that had sat unused for several months. Suspecting a flat battery, the garage sent a technician to jump start the BMW.

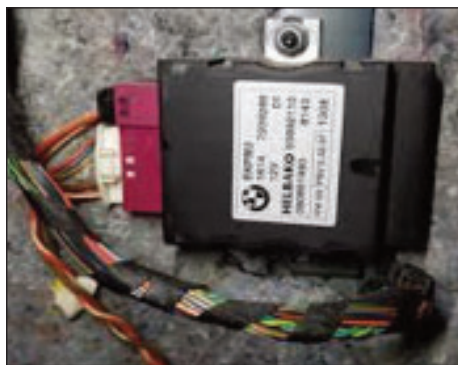
An investigation into the EKPS module wiring was required. The module is located in the Offside rear load area. As soon as the

The EKPS Module was located in the boot

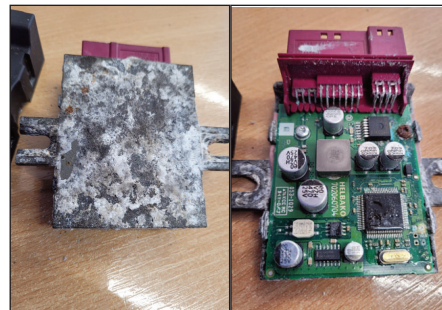
technician found the module, it was obvious that the module was the issue. Water had been leaking into the rear load area for several months, damaging the circuitry of the module. A replacement EKPS module solved the non-start issue.

An LED test light does not give any indication of voltage, which led the technician to mis-diagnose the fuel pump as being the problem, and needlessly replacing it. If he had load tested the circuit to the fuel pump, the real source of the problem, the EKPS module, would have been spotted earlier.

Signs of water damage on the exterior of the module indicated the likely source of the problem, and the interior was also water damaged
