# Xsara Picasso - Fast flashing indicators

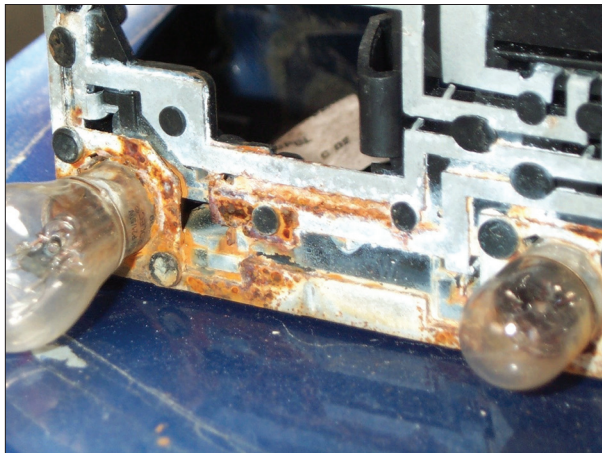
The problem on this one was actually in the bulb holder itself. Water had entered

**The corrosion in the bulb holder was preventing a good earth**

the lamp and had severely corroded the bulb holder. The bulbs had rusted into place, and the possibility of removing the bulbs and restoring the bulb holder to service was minimal. The best option was to find another bulb holder to replace the original unit.

Given that the lamp had been allowing the water to leak into the unit, the owner decided to opt for a new rear lamp, in addition to the bulb holder.
