Climate control systems and LIN components

A recent case on climate system issue gave us something different that was unexpected.

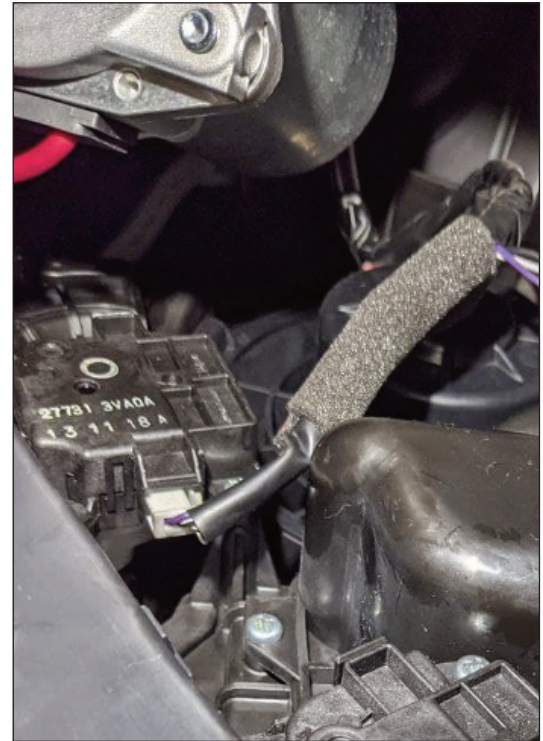
After examining the wiring diagram of the control motors fitted to this system, it was noted that they all share the same Power supply Ground and Signal lines. This means that no matter what connector they are connected to, they are assigned to a specific location within the heater assembly, and cannot be moved for test purposes.

So when replacing a faulty motor, make sure of the specific location, as this is important. They may look like all the same component and part number, but each one has a specific LIN Identity on the network.

A part may have the same number, but it has its own address on the LIN and is not interchangeable
