Piezo Injector failing intermittently

A 2008 Ford Fiesta 1.4 TDCi had been in several times to the workshop with a misfire complaint. Each time, the fault code scan revealed a circuit fault with injector cylinder 2.

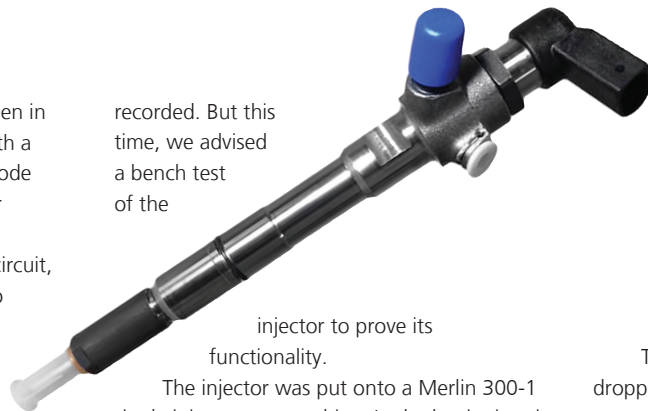
The technician repeated the test on the injector for cylinder 2 and it passed. The resistance was 200kohms, as previously

recorded. But this time, we advised a bench test of the

injector to prove its functionality.

The injector was put onto a Merlin 300-1 single injector test machine. In the beginning, it performed well. But less than a minute into the test, it failed.
