# Kuga and Ranger communication issues

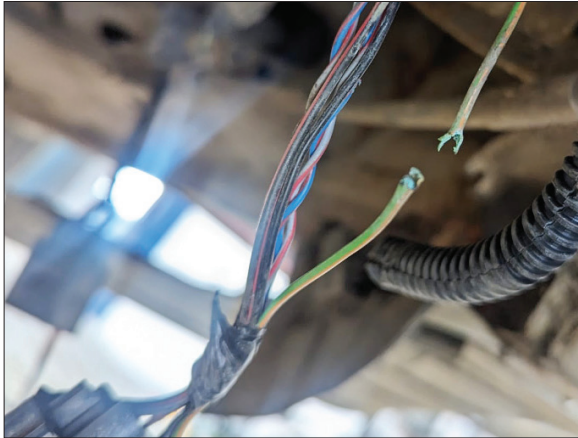
The first case was a 2013 Ford Kuga, with permanent AWD, that had a transfer module communication issue. The first mistake was to look up known cases for the Haldex module online. They have

known issues, and repairers have repair plans in place for these modules when they come across them. A quick test for power, ground and CAN signals at the module was completed and nothing was found to be wrong.

In the initial testing, the power supply was tested with the component unplugged. Loading the circuit showed a voltage drop. Tracing the loom back revealed a badly damaged wire connected to the Haldex module.
