Mercedes C-Class - Worn water pump

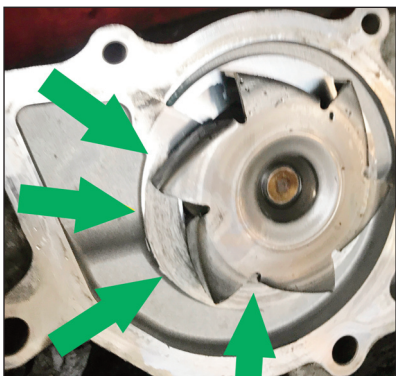
With the pump removed the wear on the body from the impeller could be seen, this was the source of the noise

Removing the belt, and starting the engine up, quickly confirmed that the noise had gone. I worked my way around the rotating components to discover which one was at fault. I soon found that the water pump had a small amount of play in it, and this was the guilty party.

Once the pump was off the wear could be seen, and with the new pump fitted and the cooling system bled out, the Merc was quiet once more.
