# Turbocharger troubleshooting

When Bernard Clarke of Clarke's Garage, Co. Cavan, was confronted with a suspected faulty Variable Nozzle Turbine (VNT), he eliminated all other possibilities before deciding to replace this costly item. Here is what he did and learned along the way.

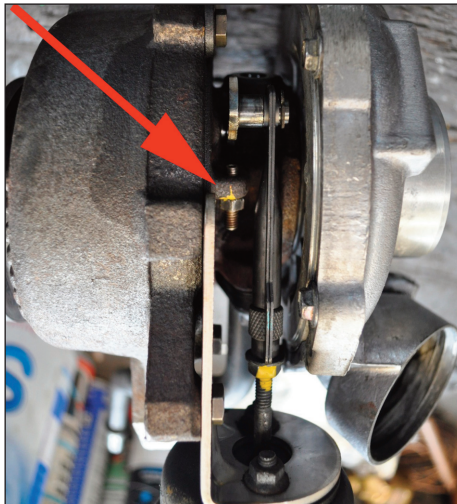
**The old VNT turbo and the adjustment for the vanes, at arrow**

The old turbo was taken apart to see what was going on to cause the fault. The vanes are controlled by a single ring that is rotated by the vacuum solenoid and moves all of the vanes in unison. All of the vanes and the ring looked fine, but if comparing them to a turbo in good condition, you would see that there was a bit of slop in every connection from the solenoid to each vane. The accumulated wear was causing the turbo to raise the exhaust pressure, causing a restriction, rather than a boost.

There is a way to adjust the vanes on this turbo, but it was only intended for adjustment at the time of manufacture, not during service or repair. Bernard suspected that the turbo was faulty, but wanted to make sure he was on the right track, so he adjusted the vanes to see the effect it would have. Adjusting the vanes is not a way to fix a turbo problem, it was used as a test method only. He initially installed a 2mm thick metal bar that prevented the vanes from going all the way back to the idle position, and then took the car for a test drive. The acceleration problem was gone and the car ran perfectly. Bernard had the evidence he needed to make the correct decision and he replaced the turbo. The car ran perfectly with a new turbo installed.

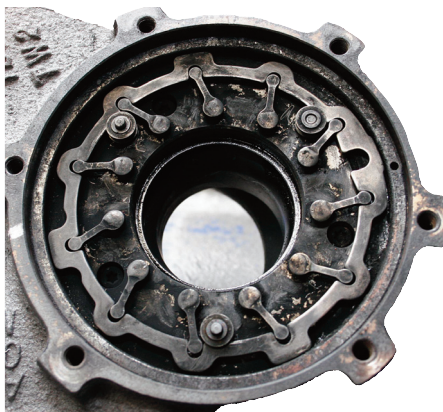
**A view of the ring that controls the position of the vanes, which change the boost provided by the turbo**
