On a mis-matched pair of DRLs small details really did matter

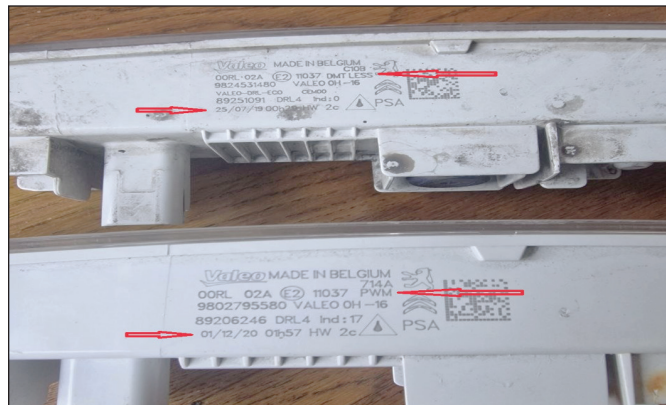
were found. Both DRL lamps were resistance checked, and it was then we noticed one was 9.6K ohms and the other 5.6K ohms.

And after questioning the customer, we learned that the car was an accident salvage. The DRLs had been replaced at the time of the repair, but they were not a matching pair.

The DRLs looked identical, but were not compatible as a pair as one was marked "PWM" and the other was marked "DMT Less"

A pair of DRLs were ordered for this 2019 model, and Vauxhall sent 2 options, "PWM" and "DMT Less". The "DMT Less" lights for

2019 models were fitted, all codes cleared and the LED side lights and the DRLs returned to working normally.
