A new turbocharger but boost is still weak

A recent call to the Autobiz Helpline, was about a Renault Traffic 1.6 dCi, fitted with an R9M turbocharged engine. The original issue was a failed turbocharger, which was replaced with an OE unit, but the issue of low boost persisted. Nothing had changed with the poor running. A fault code for low boost was still logged after re-testing. Without a smoke machine, the diagnosis relied on physical checks to the turbo actuator.

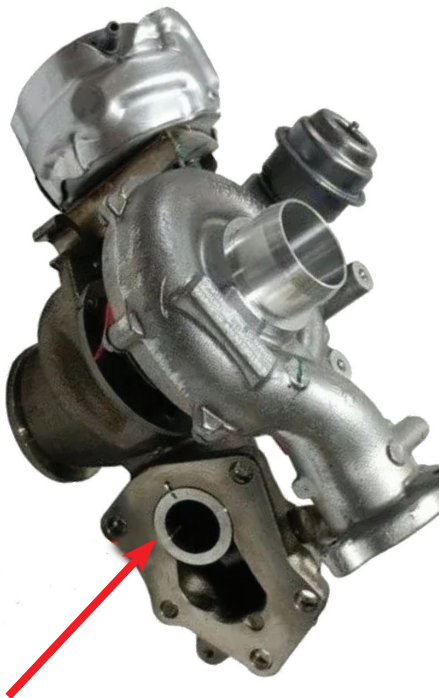
This part (at arrow) will be missing from your replacement turbocharger and is available as a separate part

This is where the dealers have an issue, they do not supply the turbocharger fitted with a sealing ring. You are required to swap this part from your old unit. But no information on this is sent when ordering the new turbo. Even though they have seen this issue in the past with a replaced turbocharger, no warning is supplied with the replacement part.
