Going deeper to solve the problem - Non Cranking 2009 Ford Focus 1.6 16V

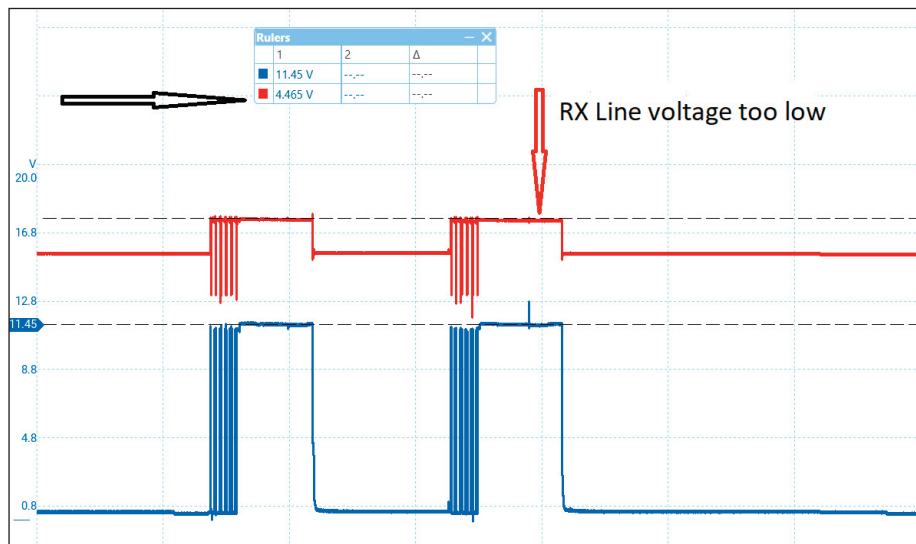
This proved a signal issue with the RX line voltage being lower than expected. The usual voltage of 11.45v on both TX and RX lines.

The issue was traced to a high resistance solder point on the main connection points to the circuit

he traced this issue to a high resistance solder point on the main connection points to the circuit.

After resoldering the connection and refitting the cluster, the issue was resolved and the Focus.
