Tim Stock

A Non-Starting but Cranking Honda with Programmed Fuel Injection - PGMFi

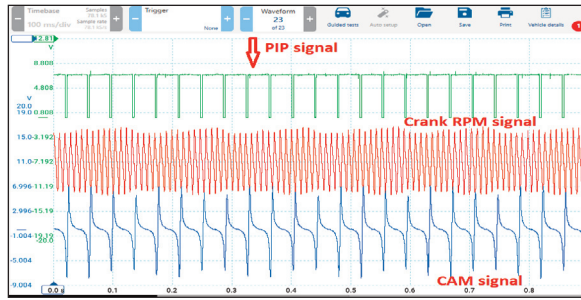
This scope trace was taken at idle and shows signals for Crank RPM and cam position, and the returning PIP to the amplifier

profile ignition control pulse (PIP) back to the amplifier in the distributor. The amplifier then controls the coil primary signal. The resistance value of the pickups is the same for all sensors, and should be between 700 ohms and 1K ohms.

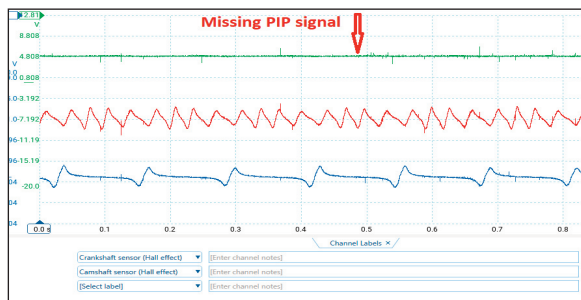
This scope trace is missing the PIP signal, and this missing signal is the reason the Civic was not starting

When the vehicle was back to a non-start situation, the missing PIP from the ECM became obvious. This was traced to the engine main relay failing to power up the ECM. The problem was traced back to dry solder joints under the centre console, a common failure point for these vehicles. Without power supplied to it, the ECM was unable to return the required PIP signal to the distributor. Checking for a missing 5-volt reference at any sensor would reveal an ECM power supply issue.
