Overheating Micra and a Golf with DTC 17656

Nissan Micra II & Cube Engine overheats and loses power

VW Golf IV (1J5) Fault Code 17656

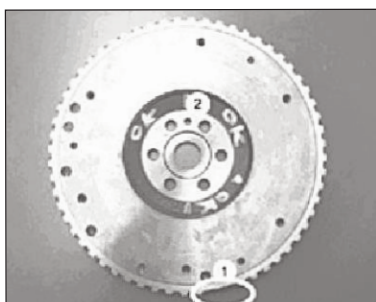
Flywheel teeth in the correct position

In the top image, you can see the correct position of the teeth with respect to the shaft by comparing it with the image on the bottom
