# Overheating Micra and a Golf with DTC 17656

## Nissan Micra II & Cube Engine overheats and loses power

## VW Golf IV (1J5) Fault Code 17656

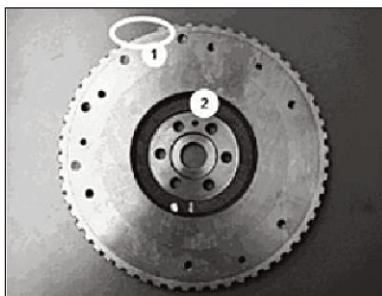
There are problems with the flywheels fitted in some Micra II models that can produce the symptoms above. The causes of which may be difficult to determine.

Flywheel teeth in the wrong position

The image of the signal shows us that the camshaft is operating out of range, an incorrect synchronisation is seen between them during the starting phase. The signal will vary depending on the origin of the fault.

If there is a problem with the synchronisation, the necessary components must be removed to access the flywheel and replace it.

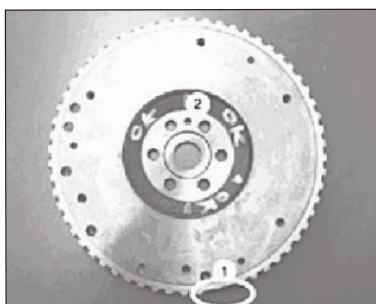
Flywheel teeth in the correct position

In the top image, you can see the correct position of the teeth with respect to the shaft by comparing it with the image on the bottom

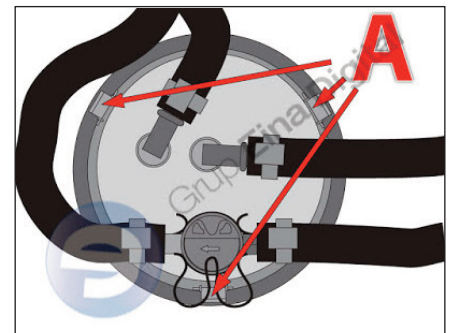
To be able to extract the fuel gauge correctly, the clips that secure it must be removed with great care. There are three securing clip positions for the fuel gauge which are located as shown in the image below.

- Read the fault codes in the ECU
- Confirm the DTC of 17656
- Check that there is fuel in the tank
- Ask the customer if they have filled up with a suitable fuel.
- Check for leaks in the fuel supply circuit
- Check for fuel impurities and quality
- Replace the fuel filter
- Clear the fault code in the ECU
