Parasitic drain evolves **into a non-start**

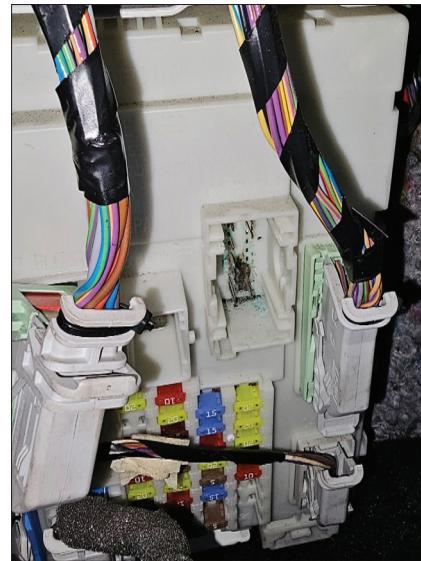
This is a very common call to the Autobiz Technical Helpline, and we sent the known solution to the technician to check a few things. It is a common occurrence on this model that the windscreen washer pump leaks, and the windscreen wash wicks up the loom, making it's way into the body control module. Once at the control module, corrosion begins to foul the pins and wiring. Then the corrosion continues into the control module, causing even more widespread damage.

Significant corrosion on this body control module connection plug, and severe damage the body module pins was quickly spotted. The extent of the damage meant that a new body module needed to be installed, and the connection plug was re-pinned. And a new washer pump was fitted.

Corrosion was caused by washer fluid wicking up the loom into the Body Control Module
