Tim Stock

Park distance control problems on a Range Rover

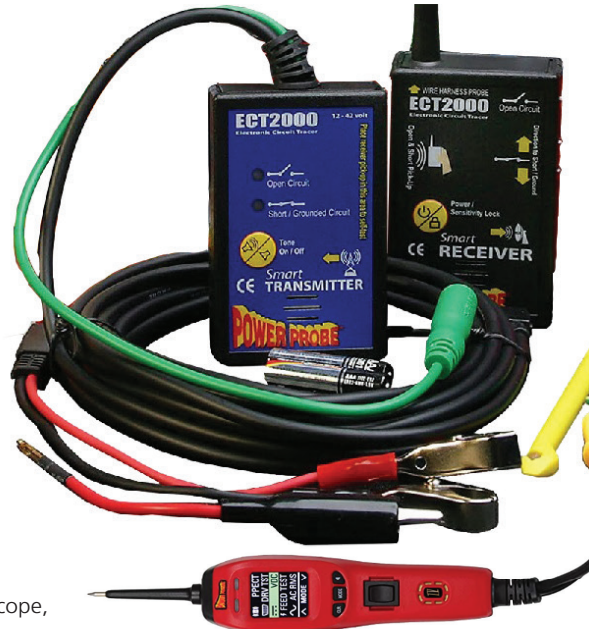
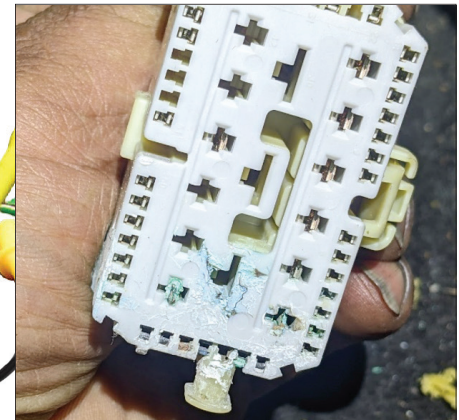
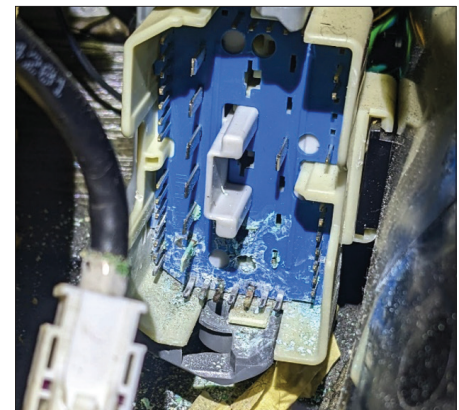
A signal was along the wiring and a probe detected if the signal was still present

So, we employed a signal injection technique, for this we used the Power Probe ECT2000 and Power Probe IV. Using the probe, a signal was sent from the bumper connector through the wiring, but did not arrive at the PDC control module under the driver's side of the dash. Working our way back down the loom, we located the signal at a connector as it passed through the bulkhead, and this was the issue, and the problem was solved

Corrosion in the connector had caused the wiring fault
