Poorly running Hilux **with fuel delivery problem**

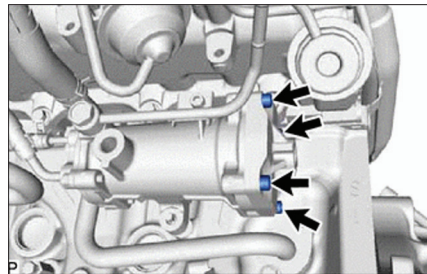
After some research, it was found that a second fuel filter is fitted on the return fuel circuit of these models. It is often overlooked during routine maintenance. Due to the location, it is sometimes missed during routine inspections. This filter is located on the engine assembly, on the left side of the engine block. It is accessible through the left wheel arch liner.

The Return Line Filter is located on the left side of the engine block and is accessed through the left arch liner

Once the filter was replaced, and the adaptations repeated, the vehicle ran well with no fault codes returning, and fuel pressure remained very stable.
