Qashqai timing issue sorted using logic

Tim Stock,
Autobiz Helpline

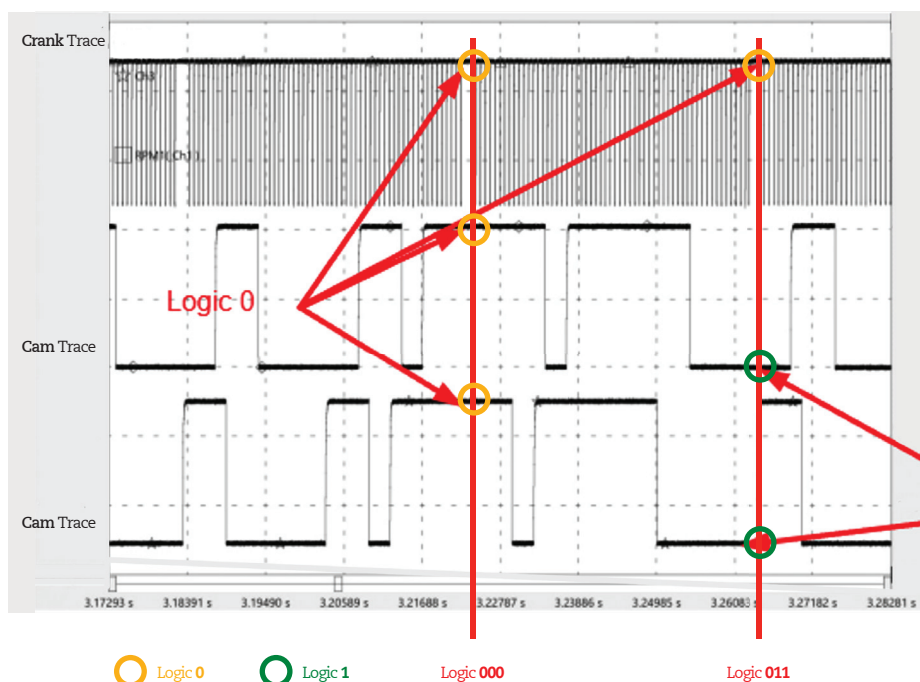
Good scope trace of a crank and two cam signals checked using logic to prove Crank and Cam correlation is correct (Logic 000 followed by Logic 011)

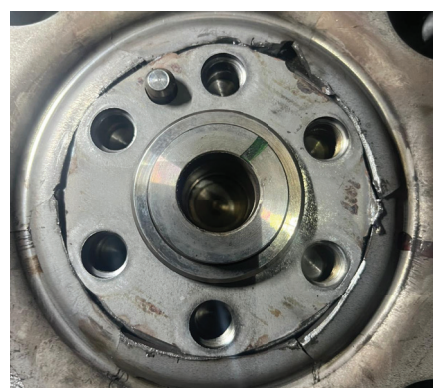
To prove that the crank signal was the issue, the crank position sensor was removed and a camera inserted to monitor the position of the reference point. The reference point was at least 100 degrees out. The transmission had to come out to prove the reluctor was the issue. With the transmission off, it was clear that the drive plate was the issue. It had spun 100 degrees and locked up, leaving the crank signal out.

Logic showed the Cam signal was at least 100 degrees off, the result of the reluctor breaking and rotating to cause this unusual fault.
