Renault Zoe refusing to charge

Variable oil pump failures

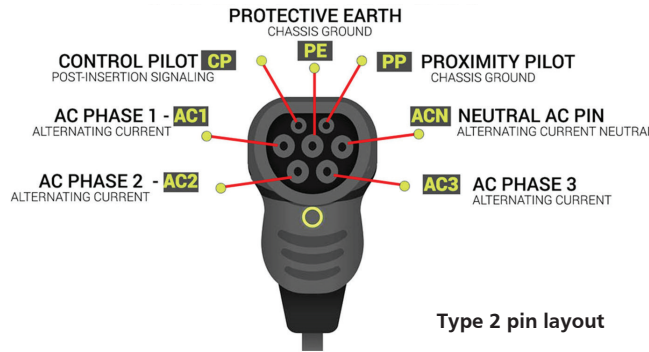
Type 2 pin layout

These are 12 volts sent from the onboard charger, and the voltage drops to 9 volts when first connected. When charging is authorized and begins, it drops to a 6 volt, 1 kHz square wave, and the EVSE

sets the duty cycle depending on the current that the charging cable is capable of. In this case, it would be 20% @12amp supply, the maximum the granny charger is capable of supplying

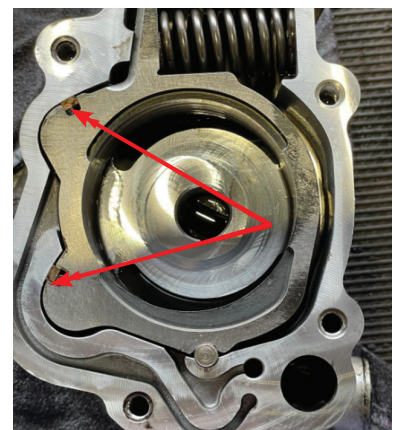
Apex seals in the correct positions
