Rover 620 - Hot brakes

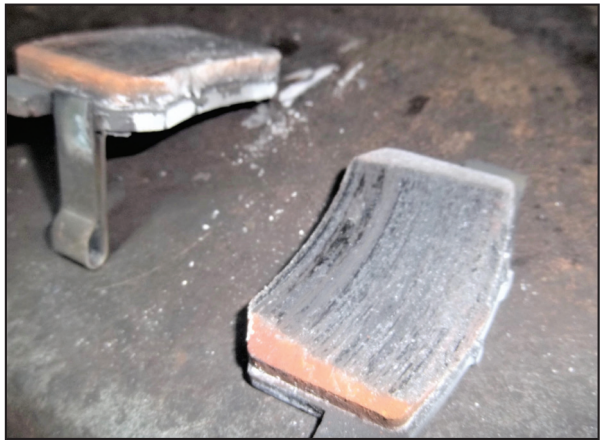
White patches on the brake pads are a sure sign of overheating and that the pads need to be changed

Whenever there were three passengers in the vehicle, the body dropped slightly and the handbrake cable tightened. So as he went on his way, he was unaware that the nearside brakes were binding slightly. When he stopped and smelt the burning brake material he asked me to have a quick look.

The surface of the brake pads had been burnt, and I recommended a new set of pads. After fitting them, I completed the job by correctly adjusting the handbrake. Hopefully, he will not carry out his own adjustment this time.
