## A Renault Scenic with multiple system faults

## Ford S-Max won't crank over or communicate

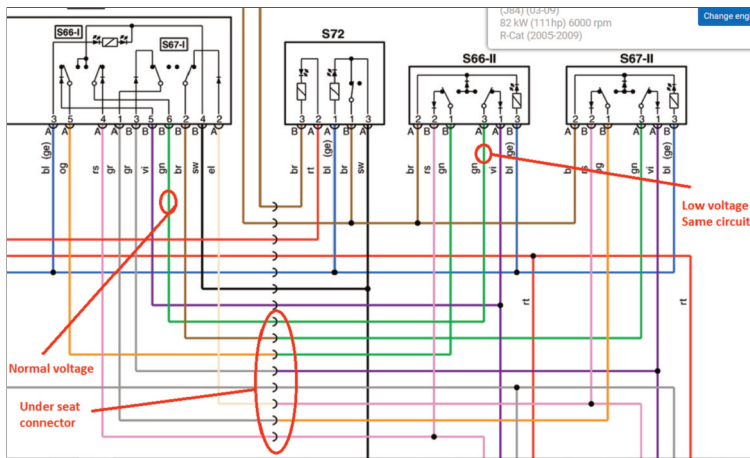
The wiring diagram identified the connector that affected wiring passed through

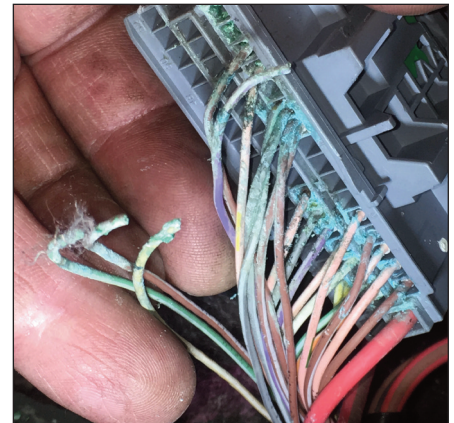
for both rear window failures. Major corrosion of the multiplug under the passenger seat and damage to multiple circuits from previous water ingress was evident.

Heavily corroded wiring in the connector was the cause of the multiple faults

But the parking brake system was also showing errors on the initial scan and vehicle check. The parking brake system also passed through the corroded connection block. So the repair was made to the connector and loom under the front passenger seat, and multiple faults were cured from one single failure point.

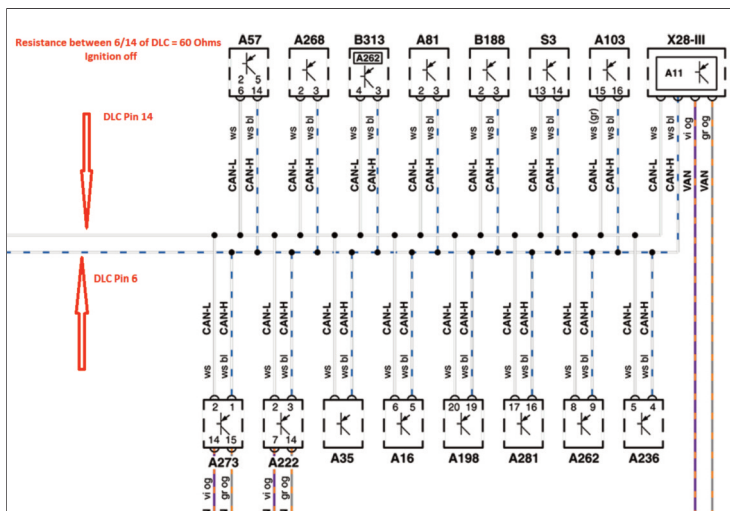
Normal resistance between terminals 6 & 14 on the OBD connector is 60 ohms

terminals 6 and 14 of the Diagnostic connector, the most readily available test point. We would expect 60 Ohms on a good/functioning system. Instead, we found a confusing situation, fluctuating resistance around 590 ohms.

This did not seem correct, so we asked for a meter check, only to find the Ohms meter was faulty. We started the test again with a new meter, and measured a stable 119 Ohms, indicating an open circuit in one of the CAN High or Low lines.

From previous experience, we have seen the power steering control module affecting the CAN network. The steering control module was unplugged, and the network resistance rechecked. It had returned to 62 Ohms and the system now powered up and the vehicle communicated. And it started with only a missing module for the power steering system.
