Always Verify...

When in time is not quite in time

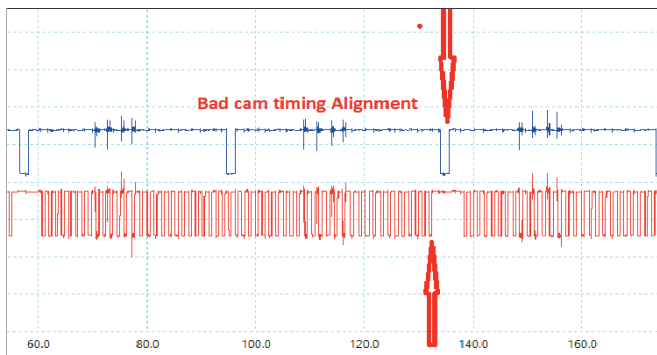
As a second confirming point, the serial data PID for timing showed a 7 degree drift from the expected value. This was what the ECM had detected on engine start.

As you can see from the Database file and the customer's waveform, we definitely have a timing drift of several degrees late on the Cam timing. The customer opted for the garage to begin again and replace the timing chain with an original part.

After the Technician had completed the repair, the timing signals were assessed and the fault code was cleared and did not return. The scope trace confirmed alignment. And was sent for us to backup our database of known good signals. With this engine the timing is aligned with coloured links 25 teeth apart to reference marks on both the cam and crank sprockets. Both of these were in alignment. Some engines are prone to chain stretch, as was the case with this particular vehicle.

This Cam signal (blue line) is out of synch with the crankshaft

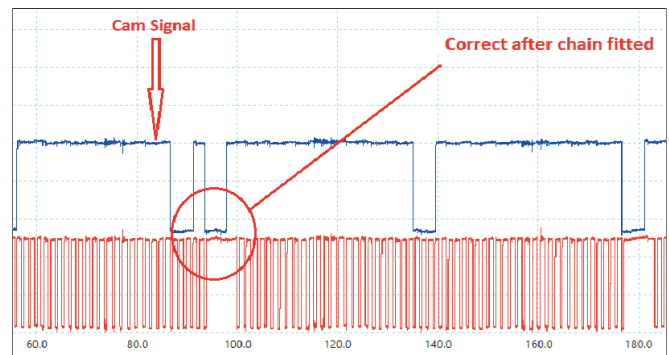
This cam signal is in synch, after a new timing chain was fitted

It is also worth noting that there is a function available to relearn the new timing chain coherence values after the repair has been completed.

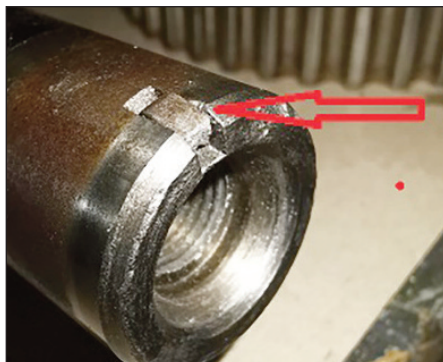
The location peg had been sheared off, allowing the pulley to slip position

But as we have seen this scenario before, we asked for the pulley to be removed from the camshaft and inspect the location peg in the back side of the pulley. It was then that he saw a not uncommon failure, the location peg had sheared off and the pulley had spun on the camshaft.

A new pulley was ordered and fitted, but the belt seemed too long. It is worth noting that the F9Q 1.9 engine has a few variations, and the Di and DCi have differing teeth counts on the timing pulleys.

The correct pulley was fitted for an F9Q 762 and the engine was retimed. The engine started with no problem or recurrence of the correlation codes.

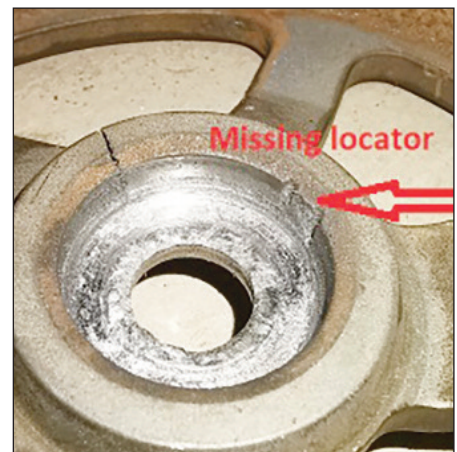
The pulley had been allowed to rotate on the camshaft after the locator sheared off
