**Tim Stock**

## Always Verify...

## When in time is not quite in time

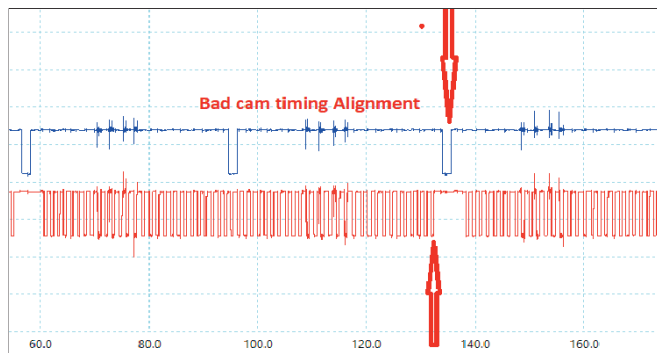
As a second confirming point, the serial data PID for timing showed a 7 degree drift from the expected value. This was what the ECM had detected on engine start.

As you can see from the Database file and the customer's waveform, we definitely have a timing drift of several degrees late on the Cam timing. The customer opted for the garage to begin again and replace the timing chain with an original part.

**This Cam signal (blue line) is out of synch with the crankshaft**

After the Technician had completed the repair, the timing signals were assessed and the fault code was cleared and did not return. The scope trace confirmed alignment. And was sent for us to backup our database of known good signals. With this engine the timing is aligned with coloured links 25 teeth apart to reference marks on both the cam and crank sprockets. Both of these were in alignment. Some engines are prone to chain stretch, as was the case with this particular vehicle.

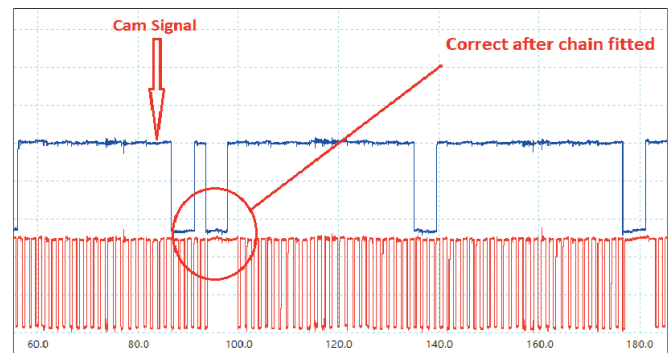
**This cam signal is in synch, after a new timing chain was fitted**

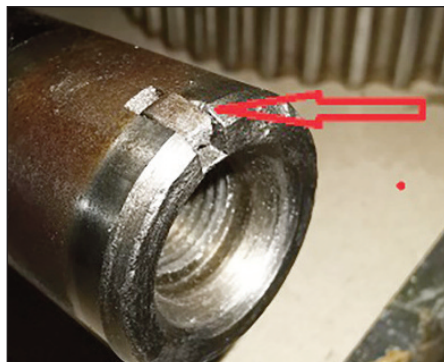
But as we have seen this scenario before, we asked for the pulley to be removed from the camshaft and inspect the location peg in the back side of the pulley. It was then that he saw a not uncommon failure, the location peg had sheared off and the pulley had spun on the camshaft.

**The location peg had been sheared off, allowing the pulley to slip position**

The correct pulley was fitted for an F9Q 762 and the engine was retimed. The engine started with no problem or recurrence of the correlation codes.

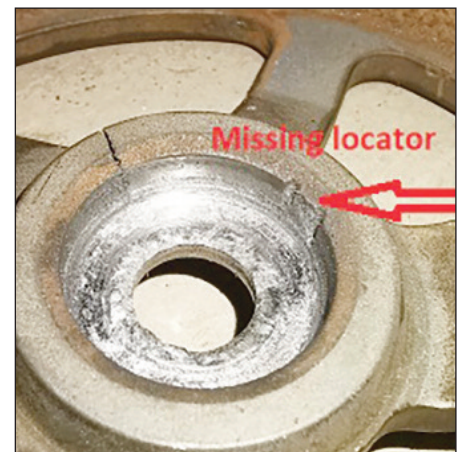
**The pulley had been allowed to rotate on the camshaft after the locator sheared off**
