## Intermittent Faults

### Case Study: 2008 Hyundai Santa Fe 2.2 CRDi

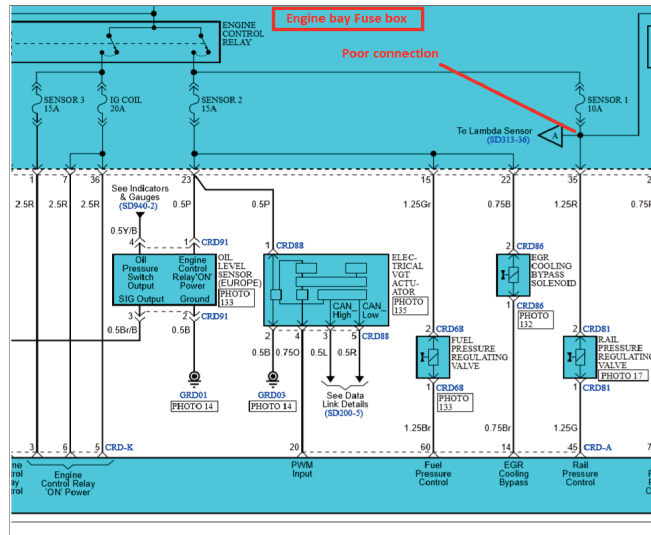
So, we decided to monitor the rail pressure signal, the rail pressure control solenoid signal, the control solenoid current, and solenoid supply voltage. Over the next few days, the signals were monitored every time the vehicle was started from cold, and on the fourth day the problem occurred. On play back of the scope trace when the fault occurred, the current was lower on the control solenoid and supply voltage dropped to 3.3 volts, indicating an issue. The supply voltage returned to battery voltage after cycling the key.

We investigated the wiring diagram for the circuit and found a splice that was responsible for the intermittent low voltage issue. The connection was

**A poor electrical connection had caused the intermittent fault**

not firm and at times would be not fully connected, resulting in a voltage drop at the connection. The loom was corrected to prevent any further volt drop problems and the intermittent problem has not returned.
