## Audi A5 - Suspected DPF problem

## VW Beetle - Rear bulb change

## Opel Zafira - Grumbling alternator

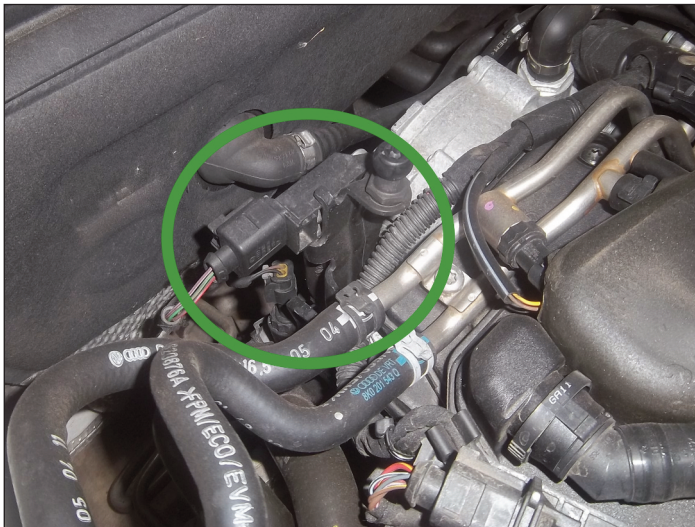
**W**ith the MIL suddenly illuminating, the owner of this 2011 Audi A5 was concerned, even though there were no problems with the drive of the Audi and it would seem no apparent reason for the light to be on. He knew he should get it checked out sooner, rather than later. We had a look and read off the code which suggested that the DPF was clogged.

We performed a forced regeneration of the DPF, and after a test drive found that the MIL was once again on. This time the code which flagged up was P2454, indicating that the DPF differential pressure sensor circuit was low (G450).

**The small pressure sensor is fitted to the top of the engine and takes no time to fit**

The unit is just under €60 and takes only a few seconds to replace. Once the job was completed, this oil burner should be good for a few more trouble-free miles.

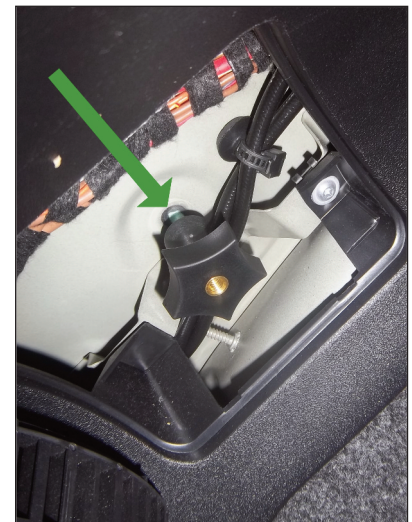
**Releasing the thumb screw should allow the lamp to then be lifted up and out**

**T**he rear light units of the VW Beetle are supposed to come out quite easily by releasing the retaining nut on the inside of the boot, then pushing the lamp unit up from the base and pulling it out, thus releasing the lamp. The problem is that when the lamp has not been removed for some time, it can become tight and stick in place.

The rear bulb change on this 2010 Beetle was made slightly more difficult, because at some point, the rear wing had taken a light knock to the area just beside the lamp. This had made the recess fractionally smaller and meant the lamp was an even tighter fit than it should be.

We did eventually succeed without either breaking the lamp or scratching the paintwork, but the same question always goes through my mind when doing such a job. What if you needed to replace a bulb on a dark night, at the side of the road, in the pouring rain?

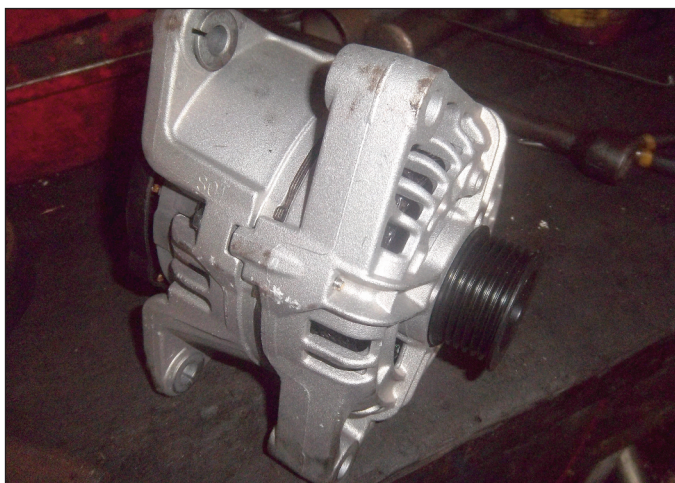
should be quite so loud and persuaded the owner to let us check things out. Removing the auxiliary drive belt and quickly starting the engine up, we noticed immediately how much quieter it was. Spinning up the various pulleys by hand soon revealed that the alternator bearings were the source of the troubles.

A light spin of the alternator pulley produced a horrendous grumbling noise and our advice to the owner was change it!

**Once the alternator had been replaced the engine became much quieter when running**

Knowing that prevention is better than cure and that sooner or later the alternator was going to fail he took our advice. With the new alternator in place the decibel level of the engine was dropped and the owner was pleased with the now much quieter operation of the vehicle.
