Ford Fiesta - Intermittent indicator

Honda CRV - Brake pipe corrosion

Opel Combo - One side indicator

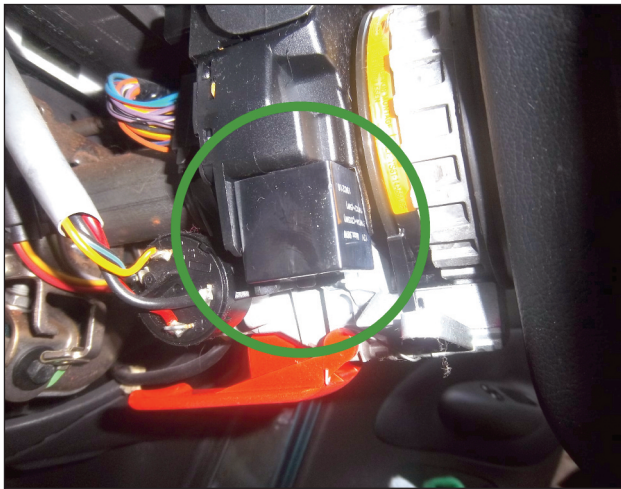
The relay unit is plugged into the indicator switch

The flasher unit on the Fiesta is plugged directly into the indicator switch assembly, and the owner was worried that the switch itself may be faulty, but this wasn't the case. Removing the securing screws from the steering column cowl, and taking off the cowl, we then had access to the switch and the relay unit.

The indicators on this 2002 Ford Fiesta, when first turned on, worked perfectly. After about two or three seconds a loud buzzing could be heard, and the indicator lamps just stayed on and flickered.

As this simply plugs in, the first thing we tried was plugging in a new flasher unit.

As we suspected (and hoped) this rectified the problems and now the indicators would flash away continuously, without any buzzing noises or problems.

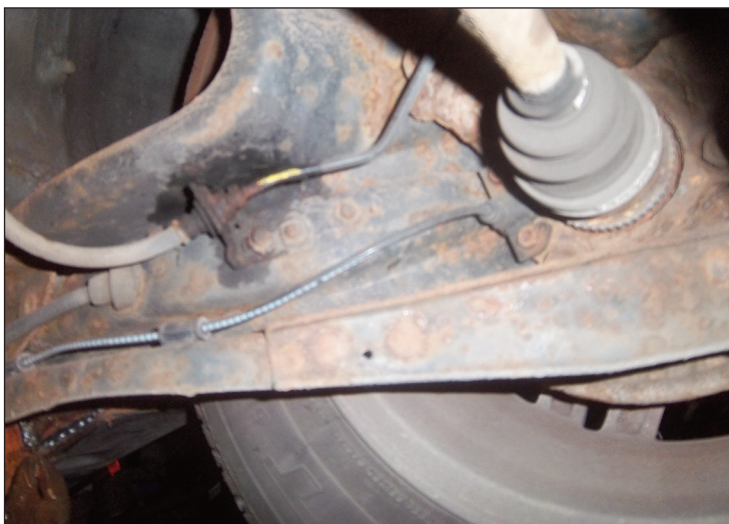
At over twenty years old, this 1998 Honda CR-V was doing pretty well. The NCT only picked up a couple of corroded brake pipes at the rear, and these being quite accessible, it should have been a simple job to replace them.

make things a bit of a challenge. The corroded brake pipes on this CR-V were not going to release easily, and although we were lucky enough to undo the wheel cylinder end of the pipe, the brake hose end was not going to shift.

Even cutting the pipe and using a six-sided socket on the brake union would not shift it. The easy solution was to also replace the brake hoses,

The corroded brake pipes were firmly rusted into the hoses, replacing these as well was the best option

which also had corroded ferrules. Our only worry was that the brake unions at the other end of the hose would not come undone. Thankfully that was not the case.

Once the new brake pipes and hoses were fitted, the brake hydraulic system was bled out and then the pressure held on the pedal to ensure all was leak free.

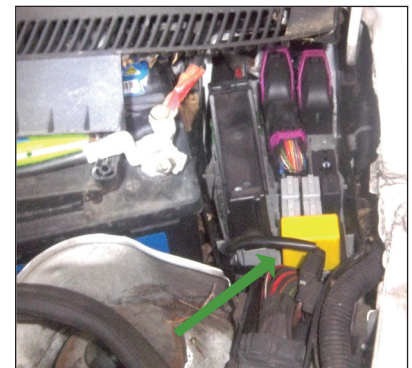
With the top housing cover removed the flasher unit is easily accessed and replaced

After being on the receiving end of a few horn blasts, the driver realised that the left turn indicator was not flashing the external lights. The bulbs were checked and found to be in good order, which meant that the flasher unit was the most likely cause of the problem.

Like the Corsa, the Combo van uses a single flasher unit which is split into two circuits, one for each side. The flasher unit is hidden in a plastic housing at the rear of the engine bay. To access it, the securing screws retaining the lid must be undone. The rear screws on this housing are difficult to get to, due to the strange angle they are positioned in.

Once the cover is unscrewed, the flasher unit is accessible and easily replaced. As expected, the flasher unit was the problem, and plugging a new one into place restored the operation of the indicators.
