Honda Civic - Swivel Removal Problem

Ford Transit Connect - Tight Nut Removal

Skoda Yeti - Failing Loom

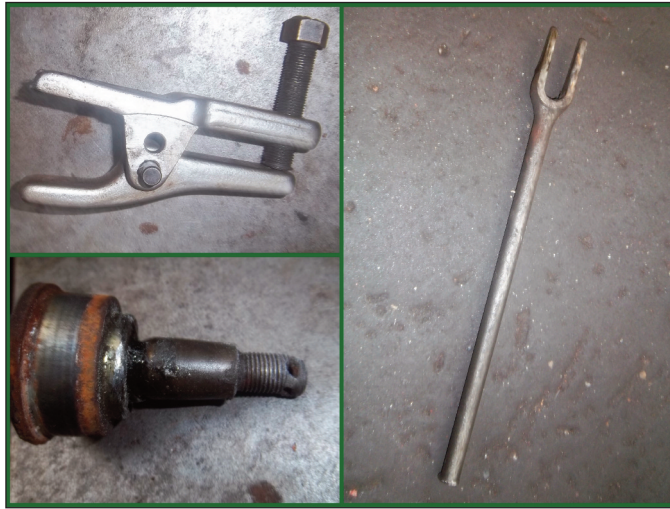
The swivel was squashed by the ball joint splitter; it may have been best to just use the fork type

pin. To accommodate this, there are two holes drilled at right angles through the threaded end of the ball joint. These two holes weaken the thread sufficiently, that when the splitter applied pressure, it squashed the thread and ruined the ball joint. The new ball joint was only a few Euros, but it meant a time delay in completing the job.

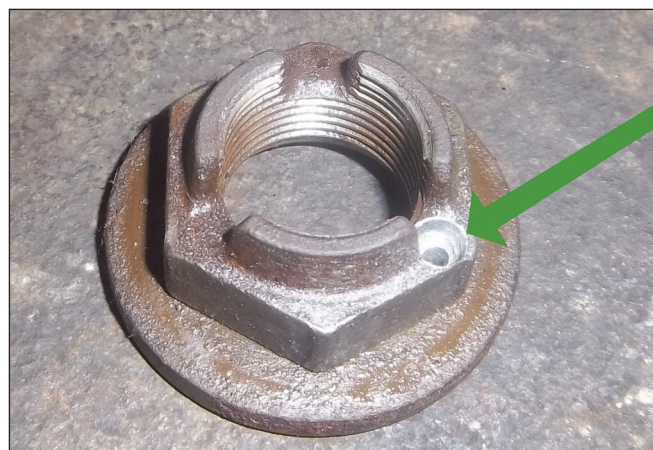
With the hub firmly locked into place, a 3/4 inch breaker bar with a scaffold tube was used to try and shift the nut. We realised how tight it was, when this resulted in sheering off the drive square on the 3/4 breaker bar. At this stage, we knew the nut was really tight!

Drilling the hole in the nut released the pressure sufficiently to allow it to be removed

The new hub bearing is supplied complete with a replacement nut and so there was no worry about causing damage to the old nut. With this in mind, we drilled a 1/8th hole down the side of the nut, then increasing the hole size slightly, another attempt was made at undoing the nut. This time the nut came undone.

The rest of the job went smoothly. Even the ABS sensor slid out of position. Once the new bearing had been pressed into place, the hub was refitted using the new nut supplied with the bearing.

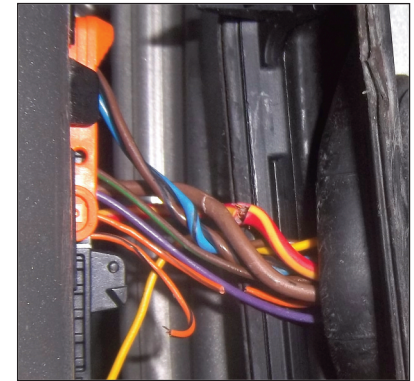
The wiring had broken under cover of the rubber boot causing the window failure

This 2011 Skoda Yeti had electric window problems. The passenger front window would open from the passenger side, but not on the driver's side. While the driver's window would sometimes open but only if the door was ajar. This was a good clue, and so the first move was to pull back the rubber cover, housing the wiring loom between the door and body.

This revealed the expected result of broken wires. If you think how often the door must have opened and closed during its life, it is to be expected that with wires continually flexing, they will eventually break. On the Skoda, the loom from the door can be unplugged. This saves any worry about having to disconnect the battery, to prevent the wires from shorting out.

I have seen this problem before, and I will no doubt see it again. For this reason, my advice is that any vehicle that comes into the workshop with central locking or window problems, it is advisable to always check the wiring between the door and body before anything else. Even if the outer sheath seem to be in good condition, it should be pulled back to examine the actual wires.

Once the plug is disconnected, the fiddly job of soldering in new sections of wire can begin. Once repaired and insulated, the rubber boot was replaced, and the loom plugged back in.
