## VW Golf TDi - Pumpe Düse Problems

## Fiat Punto - Worrying Engine Noise

## Peugeot 306 - Clock Rescue

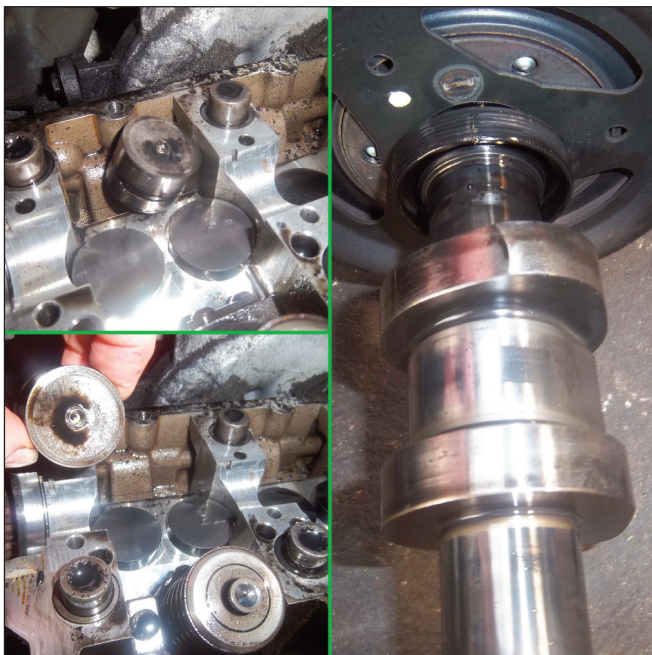
Once we stripped the top off, we discovered a cam lobe had worn down and the corresponding hydraulic lifter had been beaten to a pulp. The repair required a new camshaft, along with the shells, and a set of hydraulic lifters. Fitting the new camshaft using an assembly lubricant should prevent the possibility of damage during

**Damage was easily apparent on both the camshaft and the hydraulic lifter**

the initial start-up. This, along with an oil and filter change, should give the new parts the best chance of bedding in.

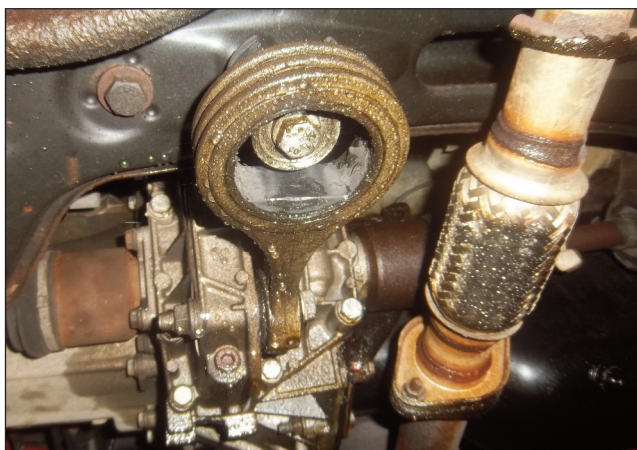
Once we received the vehicle and put it up on the ramp, we discovered that it was not an engine mount that had failed, but an engine

stabiliser bar. Although the engine was not in danger of dropping out, it was being allowed to swing backwards and forwards as the engine applied power to drive the wheels.

**The centre bush had dropped from the tie bar allowing it to fall away from the fixing**

The bar itself was an easy fix, but we had to wait for our local main dealer to order in the new part. Once the new tie bar arrived, it was soon fitted, and a quick road test confirmed all the previous knocks and bangs had now gone.

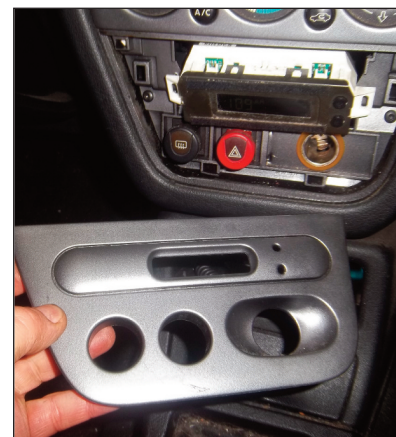
**The front trim needs to be removed before accessing the screws securing the clock**

In removing and testing the bulbs, it was discovered that they were both blown. Fitting two new bulbs and plugging in the clock, it flashed back into life. The bulbs literally flash the liquid crystal display in an array of shapes, illuminating all sections and brings it back to life.
