Volvo V70 - Broken Steering Rack

Renault Megane - Heavy Tailgate

Fiat Fiorino - ABS Failure Surprise

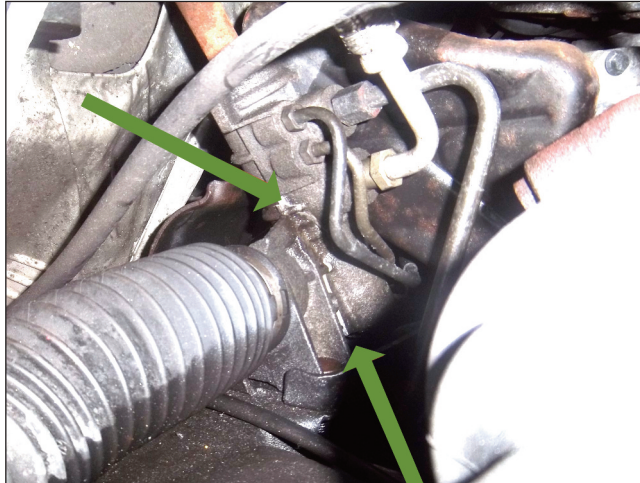
Once recovered back to our garage, we discovered that the steering rack had been broken off at the neck. This was, in our opinion, more than likely due to a collision with the road wheel by another motorist, while the vehicle was parked.

The rack was literally broken in half, most likely the result of a collision with the wheel while parked

The steering rack was not readily available from our regular factors, and with the casing being broken, the option of a repair was not on the table. This meant ordering the replacement directly from the main dealer.

Once the replacement steering rack had arrived, we could then begin the process of fitting it. On the V70R AWD, this involves supporting the engine and dropping down the back of the front sub-frame. Once sufficient space is made, the old rack can be removed and the new one fitted.

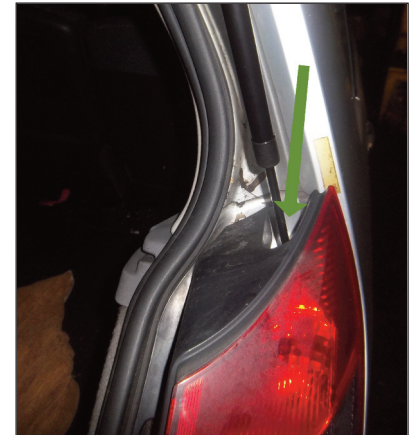
Before the struts could be changed the rear lamps had to be removed

Continually annoyed by the tailgate of her 2006 Renault Megane dropping down onto her head, this owner asked if we could make the tailgate lighter. The reason for this request was due to the failed support struts, which needed replacing.

When the old struts were removed, we discovered that one of them had zero amount of pressure left in it, which is pretty much what we expected. The owner was pleased that the danger of the tailgate dropping on her head was now alleviated.

On this Megane, we had an extra job to carry out first. The rear lamp units need to be removed to enable access to the base of the strut. Admittedly, this is not a vast amount of work, but it can be frustrating to find an extra step is needed in a relatively quick job.

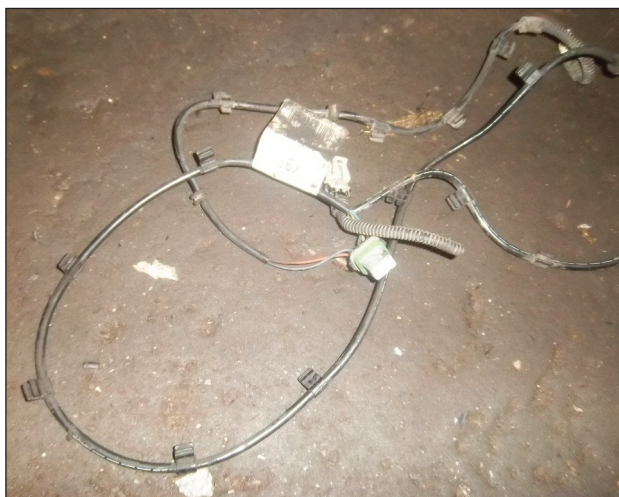
Using the Ohm meter to check the wiring, it turned out that the rear section of loom had a break within the wiring.

The wiring loom turned out to be the problem with the ABS system

This section of loom was available for a cost of £18 and once fitted the little Fiat van no longer had the ABS light on. Fortunately for us, the owner was also happy that the rumbling wheel bearing had been replaced.
