## Peugeot 206 - Seriously Overdue Radiator

## MAZDA MX5 - Engine Misfire Source

## Audi A3 - Failed Inner CV Boot

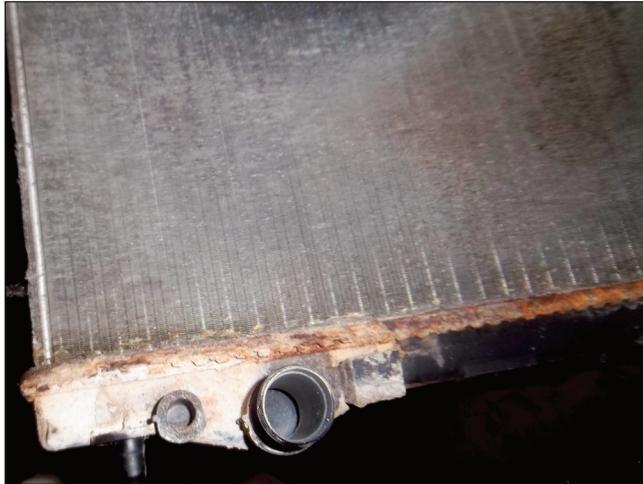
The radiator had rotted away and the only

The radiator was rotten to the core, and even the best additive wasn't going to make it a serviceable unit

solution was going to be a new radiator. Before fitting the new radiator, we flushed out the cooling system to ensure all was flowing correctly. Once the unit was in place, we then filled the system with coolant and bled it out.

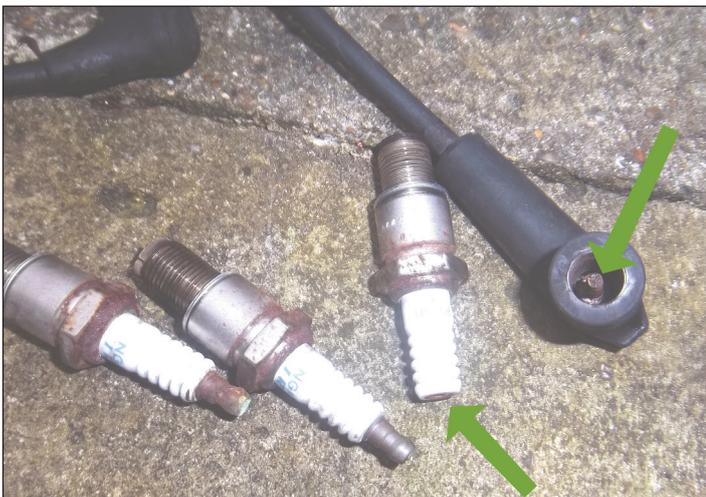
across the source of the problem. We discovered that the centre electrode on the spark plug had come away and was stuck in the HT lead.

The Spark plug had a broken electrode which had remained attached to the removed HT lead

A new set of HT leads were fitted along with the new spark plugs. The MX5 started up with far less effort than it had previously taken, and the engine sounded much smoother.

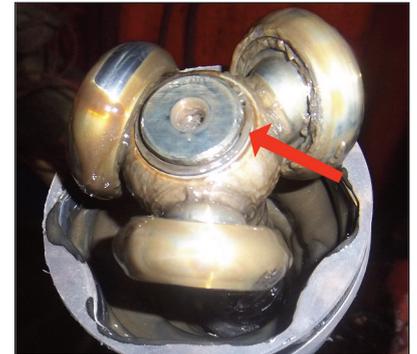
Inner CV boots pretty much stay inline, so they are less common to fail. The inner driveshaft boot on this 2006 Audi A3 Automatic, had failed around the fixing clip onto the driveshaft, allowing the grease to flow out of the boot.

Once the circlip is removed the inner section of the joint will slide off the shaft

Replacement of the inner boot on this vehicle is actually slightly easier than the outer boot. Once the driveshaft has been disconnected from the outer hub and slid out of position, the inner boot securing clip can be released, allowing the inner joint to simply slide apart.

Making sure not to knock the three rollers, the shaft can be secured in a vice and the securing circlip removed. The inner section of the joint can be slid off the shaft, allowing the old boot to be removed and the new one fitted.

Replacement is, as is always said, "in reverse order", but with the addition of a little fresh grease before securing the inner clip.
