Volkswagen Golf - Antiroll bar knock

Audi A4 - Top swivel change

Peugeot 1007 - Cure-all ABS sensor

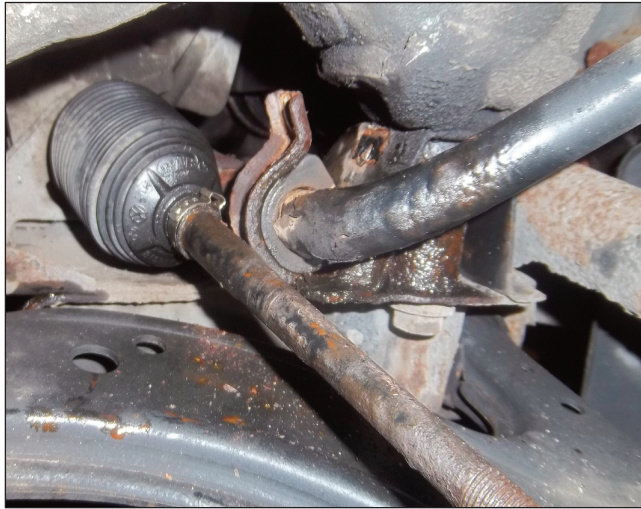
The source of a very loud knocking noise can often be a surprisingly small bush. The humble D bushes on the antiroll bar often fail, allowing a tiny contact point between the bar and the metal frame. They can also go hard with age, and no longer provide a firm support for the antiroll bar. As in the case of this 2002 VW Golf, this allows a slight amount of movement of the antiroll bar in the bush, producing quite a loud knocking noise.

Removing the drop link, allows more movement and easier fitting of the new D bushes

Replacing the bushes is a simple enough task, and it helps to remove the link arm to give the antiroll bar a little bit more movement. It also helps to replace the bush carrier bracket, and use a slightly longer bolt than is originally fitted. An extra 5cm on the length of the bolt is easily accommodated, but makes fitting much easier.

The bushes are not symmetrically shaped, and will only fit properly in one way. Once the new bushes were in place on this Golf, the owner immediately noticed the lack of the knocking noise that he had previously been putting up with.

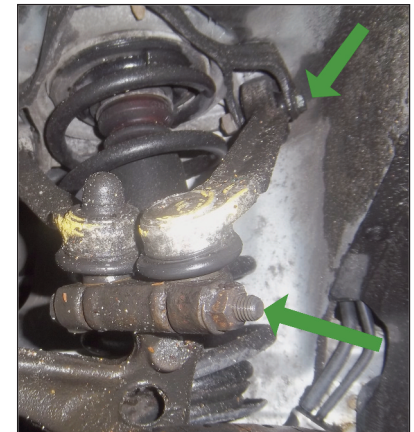
The long pinch bolt holding the swivels can often seize into place, the front securing bolt is too long to remove without moving the strut top.

The A4 has two top swivels, both are attached to a top arm. There is one potential problem which we come across regularly when replacing these. The long bolt, which goes through and clamps both swivels into place on the hub carrier, can corrode and be difficult to remove.

In the past, we have had to cut off the head of the bolt and then remove it by winding the remaining portion back on the thread with the nut. A new bolt then needs to be fitted.

This job went without any problems though, and the bolt came straight out. All that was left to do was disconnect the inner bolts. Because the front bolt is too long to come straight out, this means that the strut top mount must be disconnected and with the suspension dropped down, it can then be pushed to one side. This allows enough room for the bolt to be removed, and replaced.

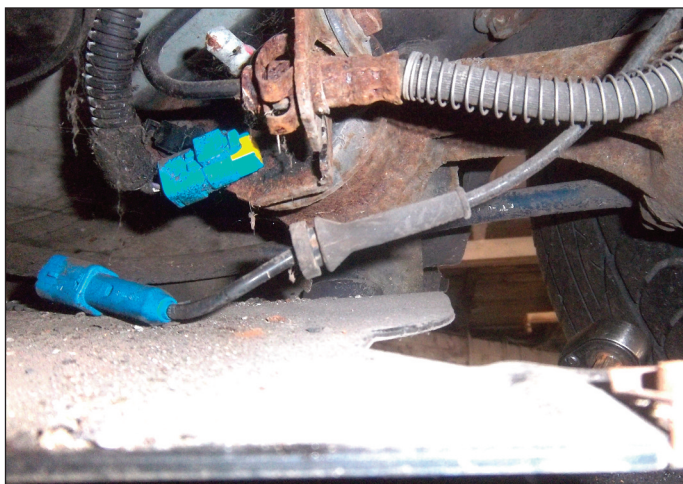
Reading the codes from the ABS system, we discovered that the offside rear ABS sensor had failed. Before ordering up a replacement sensor, we checked the continuity of the loom and connections to ensure that this wasn't the source of the problem. With the wire unbroken and the connection clean, the old sensor was removed and when fitting the new sensor, the code was cleared and the vehicle road tested.

The sensor wire and connection was checked before replacing the old ABS sensor
