Renault Clio - Handbrake Adjustment Correction

Honda Logo - Unsuccessful Repair

Fiat 500 - Lower Suspension Arm Job

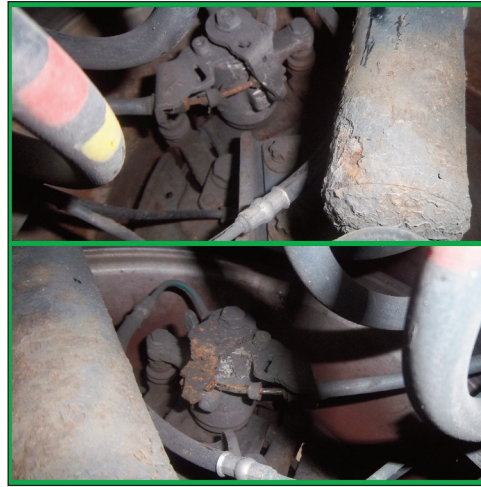
We then find that the cable has been over tightened and is not allowing the handbrake levers on the brake callipers to retract fully. This prevents the callipers self adjustment mechanism from operating as the brake pads wear, decreasing the ability of the handbrake to operate as designed.

Releasing the tension on the handbrake did not allow the calliper levers to retract fully. It was discovered that the cables had partially seized,

Once the cables were released the calliper levers returned to the back stop

possibly due to the very limited movement they had been confined to.

With a pair of new cables fitted and the handbrake correctly adjusted, the Clio now had a handbrake fit for purpose.

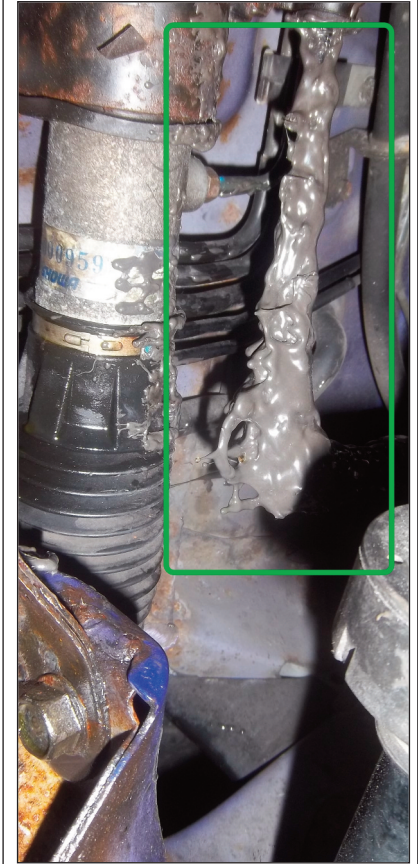
The plastic cover had not been successful at stemming the flow of leaking fluid

One of our regular customers purchased a 2001 Honda Logo which appeared to be a nice little runabout. Checking it over, we discovered that it was suffering from a power steering fluid leak. A closer inspection revealed that this was coming from the pressure hose to the power steering rack, where someone had made a very poor attempt to repair the leak by dripping melted plastic over the failed area.

The reason for this attempted repair became obvious when we discovered that the pipe was no longer available. Cleaning off the plastic we discovered that the metal pipe had a small hole, which had been caused by it rubbing against the bracket. We managed to braze it up, completing a proper repair.

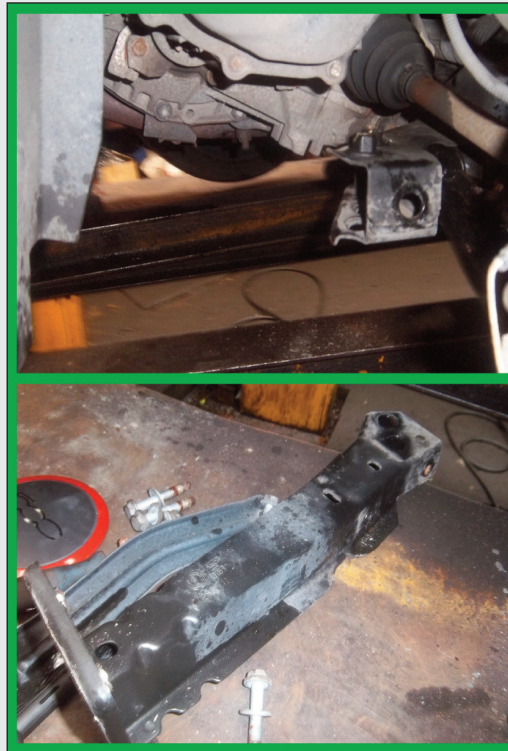
This 2012 Fiat 500 was in need of a new nearside lower arm after failing its NCT. The job of replacing the lower arm, at first, appeared to be quite a quick and simple process. A closer inspection showed that the bolt securing the front bush of the lower arm was not easily accessible.

To get to this bolt, a box section fitted between the front panel and sub-frame needed to be removed. Even this turned out to be worse than expected, as the nuts securing the front of the box section to the front panel were captive.

This means that the only way to unbolt this short box section, is to first remove the front bumper to gain access to the securing bolts. The set up is very similar to that we have come across on the Renault Megane.

The box section needs to be removed before the arm securing bolt can be accessed
