## Opel Combo - Steering Rack Surprise

## Audi A5 - Clutch Replacement

## Peugeot 207 Sport - Collapsed Oil Filter

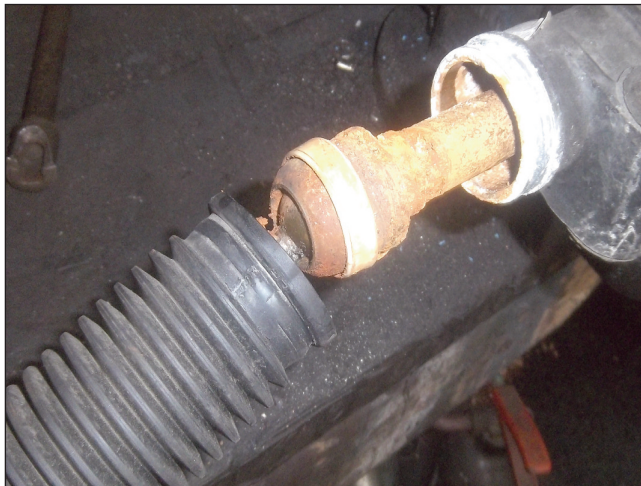
With the rack off, we noticed that the rack boot securing clips on the offside were different to those on the nearside. Out of curiosity, I removed the offside boot to discover that the steering rack was red with rust. My assumption on this, is that at some stage, the rack boot had failed and been

**The steering rack had excessive rust in the unit cause by a lack of lubrication following a boot replacement**

replaced, but when it was replaced, insufficient care was taken to ensure that the steering rack mechanism within the boot was lubricated.

Jacking the vehicle up and feeling the amount of play at the front wheels confirmed that the steering rack was going to need replacing. Not too difficult a job on the Combo van, the sub-frame does need dropping slightly to give sufficient manoeuvring room, but this is not too much work.

If better attention had been paid to detail when the boot was fitted, it may have saved the cost of the replacement rack, now being carried out.

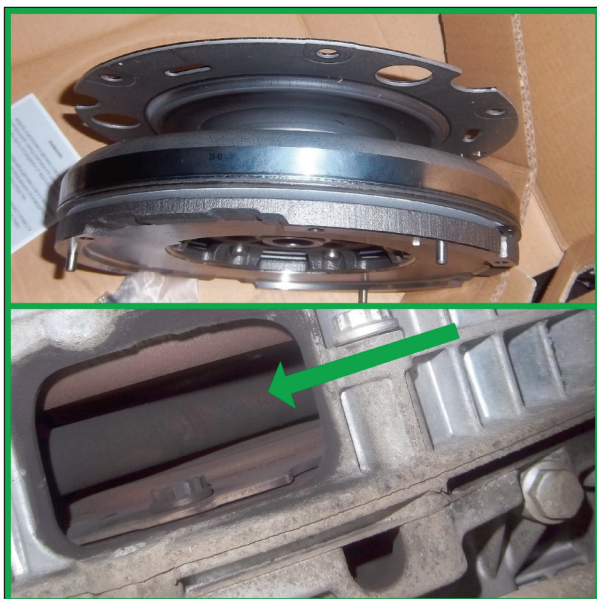
the inline gearbox, that one of the drive-shafts actually passes through bell housing and sits in a gap in the DMF. The clutch unit is bolted to the DMF and the whole assembly needs to be removed complete with the gearbox after unbolting it from the drive plate. This is similar to unbolting a torque convertor to remove an automatic gearbox, but with the added weight of the heavy flywheel.

**The drive shaft runs through the specially designed DMF unit**

Once unbolted, the six-speed gearbox, the DMF and clutch assembly needs to be lowered out of the vehicle. Once out, the nearside driveshaft which runs through the bell-housing can be removed, allowing the clutch and flywheel assembly to slide off the input shaft.

The new DMF and clutch needs to be assembled before refitting onto the gearbox. Once in place, slide the driveshaft back into position.

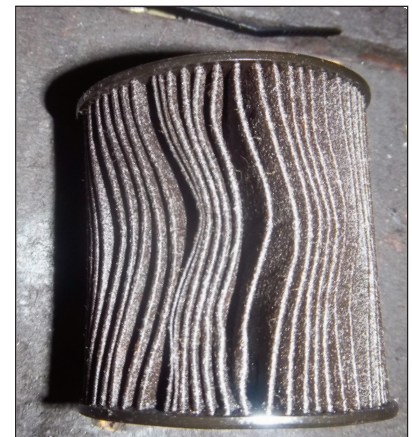
**The oil filter was well past its best and was collapsing due to blockage and age**

When we removed the cartridge type oil filter, we were immediately aware that this was well past its serviceable life. When a cartridge filter begins to clog it will start to collapse as the oil struggles to draw through it. This often makes it appear as though the filter has been squashed in the housing. Looking deeper into the folds of the filter element, we could see copious amounts of congealed oil deposits.

When we removed the drain bung we were surprised to discover that almost nine litres of oil drained down from the sump. The system should only take around three litres with the oil filter, so it was dangerously overfilled. The owner had been topping up the oil, but hadn't been checking that it needed it!

With the oil and filter change complete, all the noises and problems were gone.
