Understanding Long Term Fuel Trim - a hidden gem that will save you time and money

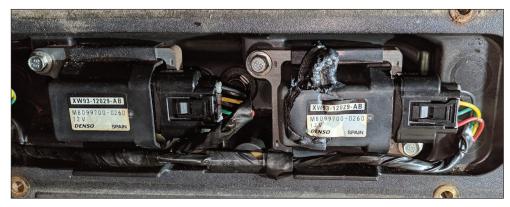
I instructed the garage to make a guick check of the LTFT figures. As this was a V8 engine, there were 2 banks to investigate. The data showed that bank 1 was running with a LTFT figure of +7%, adding fuel to compensate for the excess oxygen from a misfire. Bank 2 was at 0%, perfect mixture control.

Just one look at the failed coil, on the right, confirmed the diagnosis

Current testing the RH bank of coils identified a coil shorted on the primary side. As the customer did mention the fuse for the ignition coils did occasionally blow, the fault was found and the coil replaced.
