## Renault Trafic R9M 1.6 Bi-Turbo Non-start

## 2008 Citroen Relay/Jumper III 2.2 HDi with EGR problems

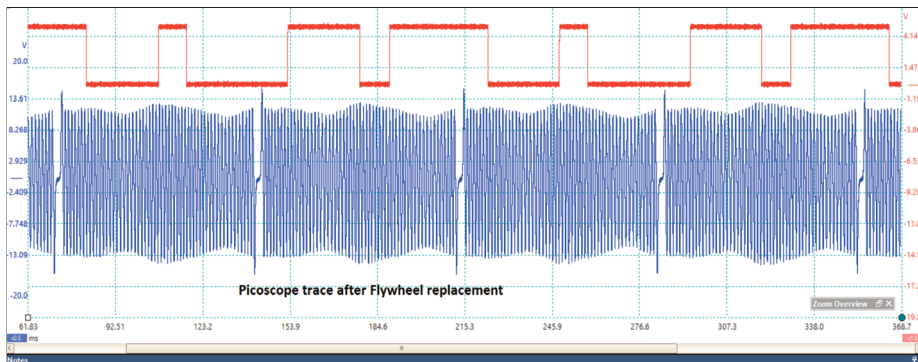
I was called in to assist with the diagnosis, and we began with the injector process. It was found that there were no signals after one single pulse on cranking the engine. Because the trace they had was from a budget scope, a Picoscope was used to confirm the correlation of the 2 timing signals. This did not conform to any known timing wave forms for this engine. We used the Picoscope waveform library to reference a known good signal.

The scope trace from the cam and crank sensors, after the flywheel was re-installed

The flywheel was refitted with the alignment corrected, and the engine started on the first turn of the key.

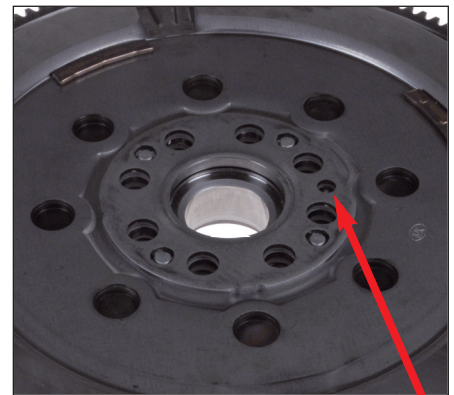
When the flywheel was removed to check fitment, it became apparent the flywheel was 180 degrees out, but the locating hole in the crankshaft and flywheel do not have a locating dowel fitted from new, and the inexperienced technician missed this, even though he had compared the new flywheel and tooth count to be correct, as he had previously been shown to

be vitally important when replacing any timing related component.

An alignment hole on a flywheel, at arrow

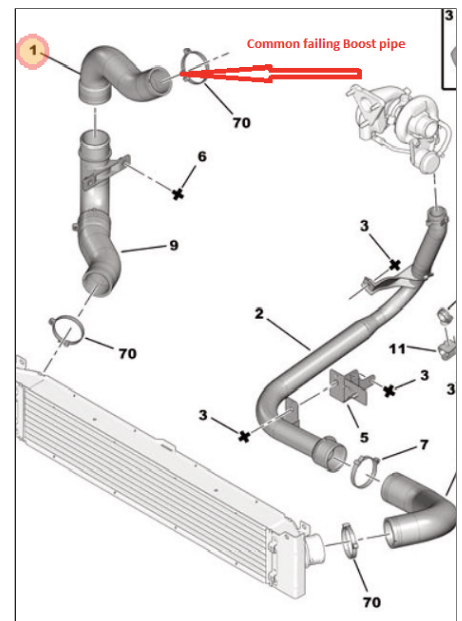
Then the actual fault was found, A split pipe from the EGR valve to the intercooler/boost pipe had been missed when fitting the valve, this feeds the Exhaust gas

The hose, at red arrow, that has been found to be split on many 2.2 Puma HDi engines

from the EGR valve into the intake system.

This info was passed to several garages with similar vehicles. On checking their problem vehicles, they also had the same split pipe. So, this is coming up as a common issue to vehicles fitted with the 2.2 Puma HDi based engine.

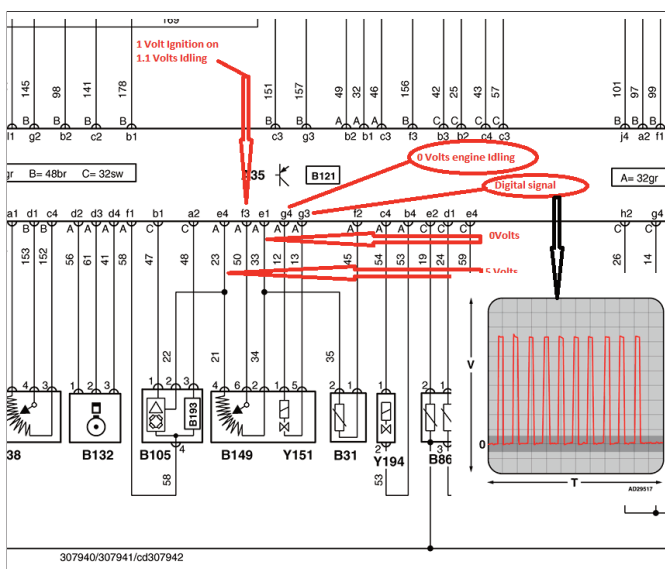
This did not solve the running and fault code issue, so it was decided to test the control and feedback circuits for the EGR system. A test plan was given to the garage to follow and then report back.

The technician reported all wiring tests passed the test plan given. As the code referred to low flow and the passage ways to the EGR appeared clear, a smoke test was performed.

EGR waveform and connection points for scope leads
