Toyota Aygo - Wiring failure

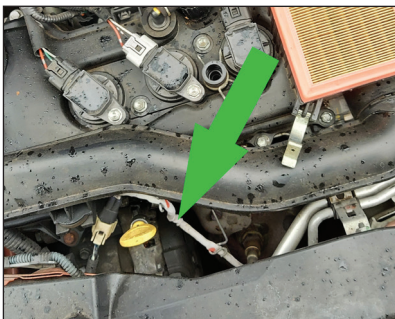
Although both of these faults could have been caused by a faulty sensor, it is always good not to jump to conclusions and to test the circuit involved before replacing the sensor. Although in this case, if the sensor had been replaced, the problem would have been cured. This was not because the sensor itself was faulty, but because the loom between the sensor and the plug (which would have been replaced) was the source of the problem.

Where the wiring loom had been fixed to the securing clip and held against the cylinder head, it had rubbed through. These sorted wires were the reason for the illuminated light and the trouble codes.

A soldering iron and insulating tape repair to the wiring saved the sensor from being replaced
