Used Volvo XC90 losing power

Keith Shanahan,
Shanahan Auto Services

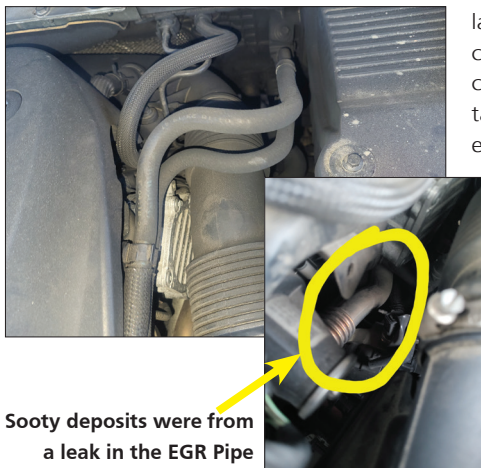
I started with a visual inspection of the Volvo. While looking under the bonnet, I noticed the distinct smell of exhaust fumes and a deposit of sooty dust on the passenger side of the engine bay. I removed the engine cover and immediately saw oil sprayed underneath it and across the inlet manifold.

Sooty deposits were from
a leak in the EGR Pipe

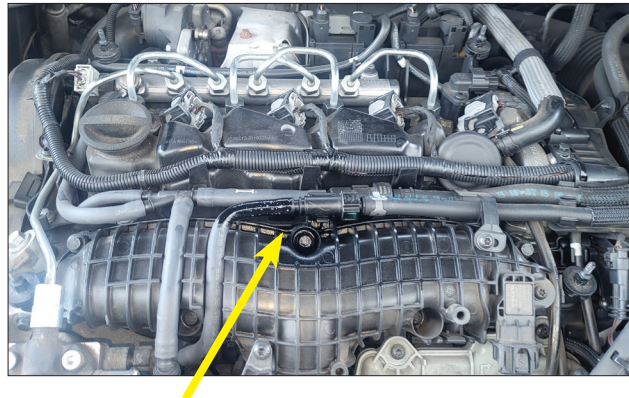
Oil residue (at arrow) indicated leak on inlet manifold

I decided to carry out smoke pressure tests on the intake and exhaust manifolds. During these tests, I found a broken EGR tube, which was the source of the soot deposits and exhaust smell. Continuing to look for any other faults, I also found a leak in the inlet manifold. The intake manifold was leaking at its centre, along a seam by a bolt hole.

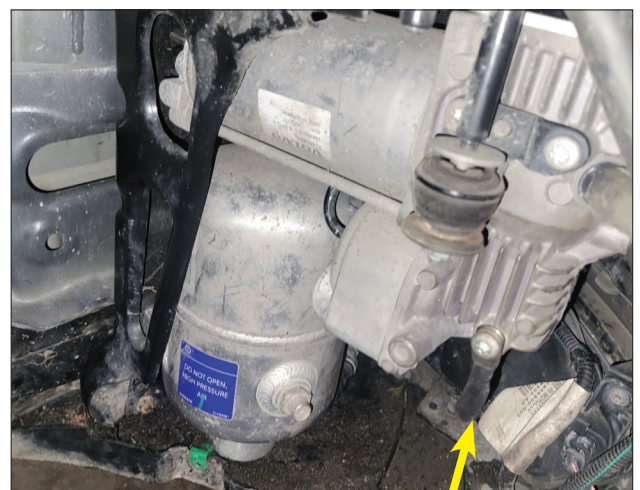
What peaked my interest though, was the PowerPulse fault code P1065 (PowerPulse temp sensor short or open). The PowerPulse system is basically a way of spooling up the turbo to reduce lag. It allows already compressed air, from a compressor-filled holding tank, be injected into the exhaust manifold. This rapidly increases flow of exhaust gasses, which increases the rotation of the turbocharger. The fault, referring to a temperature sensor lead me to inspect the compressor to check

The temperature sensor actually looks like an earth cable connector, but on closer inspection there

The PowerPulse temperature sensor (at arrow) looked more like
an earth cable connection point

were two wires into it. When the insulation wrap was removed from the wiring, I found that one wire had broken. I carried out a repair of the wire. This allowed me clear the fault code, which was permanent up this point.
