# Renault Zoe refusing to charge

# Variable oil pump failures

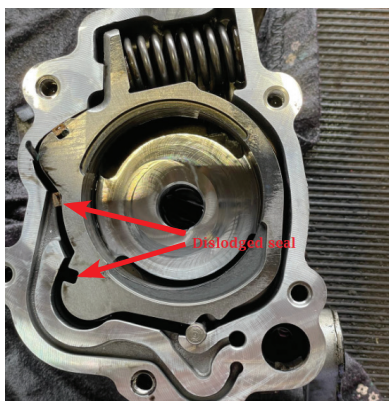
A dislodged apex seal had jammed the pump

We have also seen mechanical failures within the pump itself, due to the design of the internal components. No matter the cause, the failure has to be corrected properly.

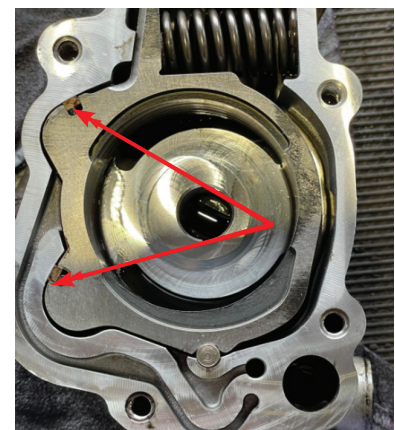
Apex seals in the correct positions
