VW Amarok Gearbox or Bearing Noise?

Peter Farrell,
PJF Motors, Tuam

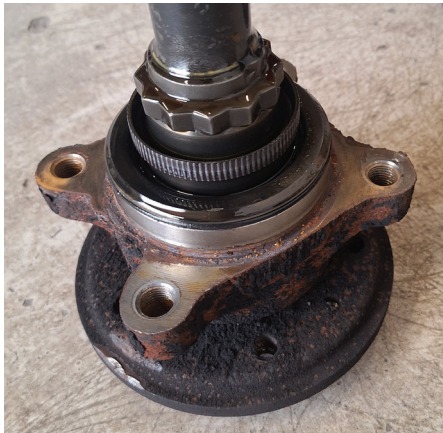
The wheel bearing and ABS sensor ring are held in place with a crimped nut threaded onto the axle shaft

Each wheel bearing is kept in place by a locking nut. Be aware that there are right hand threads on the locking nut on the right axle, but there are left hand threads on the locking nut on the left axle. After properly torquing the locking nut onto each axle, the top thin edge of each locking nut should be dimpled into both keyways, on each axle shaft. This prevents the nuts from tightening or loosening as the axles rotate.
