# Not starting immediately after servicing

**Tim Stock,**  
Autobiz Helpline

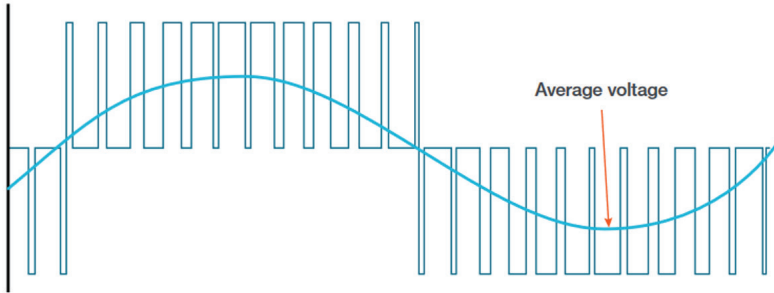
**Single scope trace of one of three phases supplied to the fuel pump (all three should be 120 degrees apart when compared)**

Calling the Autobiz Technical Helpline for advice, we explained this system has a 3 phase fuel pump, controlled by a pump module, and not a relay that he was searching for. We asked for the 3 pump phases to be scoped, to check for correct operation from the control module, using the pump ground for all channels. The scope traces showed all 3 phases were lined up, when they should have been 120 degrees apart. This pump could never run.

When a new pump control module was fitted, the scope showed the correct phase shift, and the pump ran as expected. The results were shown to the customer, and explained that it was unfortunate, but it had not been the result of any work performed during the service. The customer understood that this was going to happen eventually, even if the vehicle was serviced correctly.
