VW Touareg - Centre Prop-shaft Joint Failure

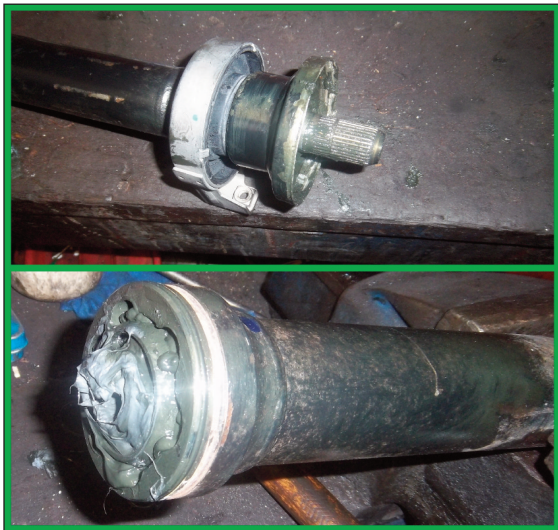
With the prop-shaft separated the centre bearing can be replaced

When the centre prop-shaft joint on this 2006 VW Touareg failed, producing vibration and loud knocking noise from the centre of the vehicle, we were surprised that our local factor did not stock a replacement unit. The local main dealer did, but this was around €850. Deciding that there must be a better way, we discovered that our local factor did carry the centre bearing for a price tag of under €100.

The prop-shaft, at first glance, appears to be sealed in the centre making the replacement of just the bearing a difficult job. This is not strictly true. Splitting the shaft involves gently prising off the metal collar by levering the metal retainer away from the joint. This will allow the boot to be pulled back away from the joint and will then reveal the circlip securing the front shaft to the joint in the rear shaft.

Once the circlip is released, the position of the two shafts should be marked to ensure they are refitted in the same position. The two shafts can then be separated. This allows the bearing and centre carrier to be tapped off from the front shaft. Do not secure the bearing and attempt to

Refitting is in reverse order and the metal collar can be reaffixed by gently peening the edges over. The collar has a built-in rubber seal, so providing the edges are peened over sufficiently it will not leak grease.
